Appendix A

Site Inspection Photographs

Photographs Taken During Site Inspection: October 7, 2009

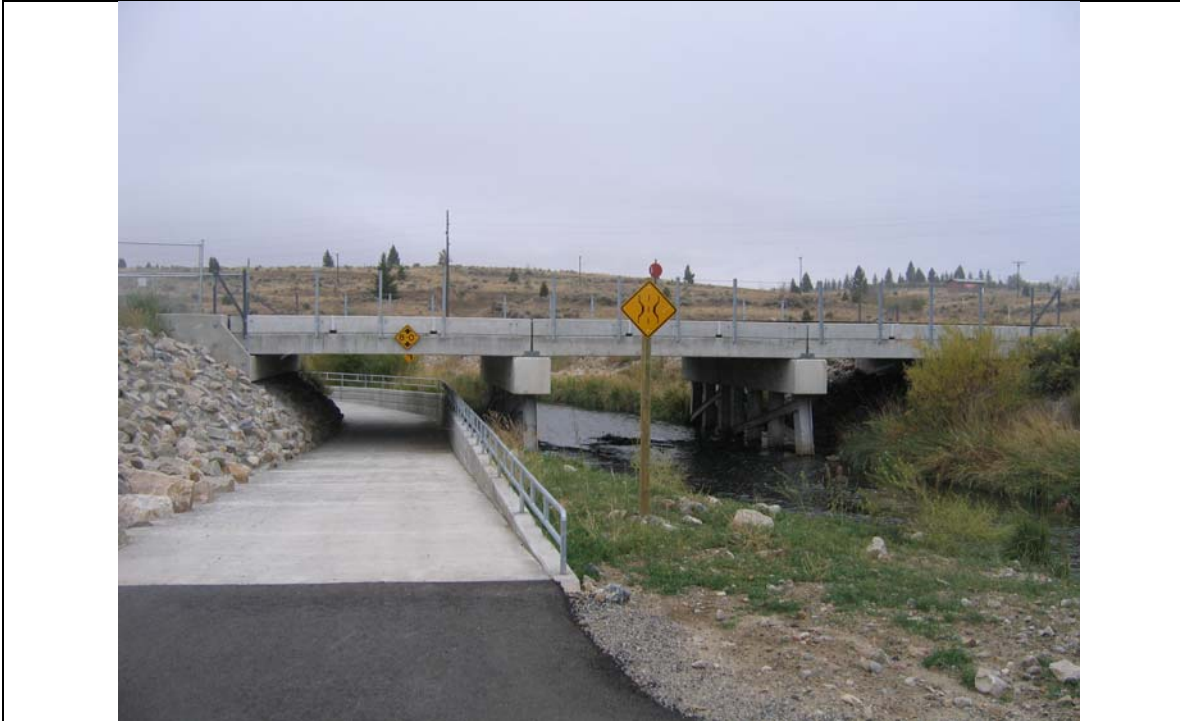
Photo 1. New recreational trail (Greenway Trail) along Silver Bow Creek near the Rocker OU

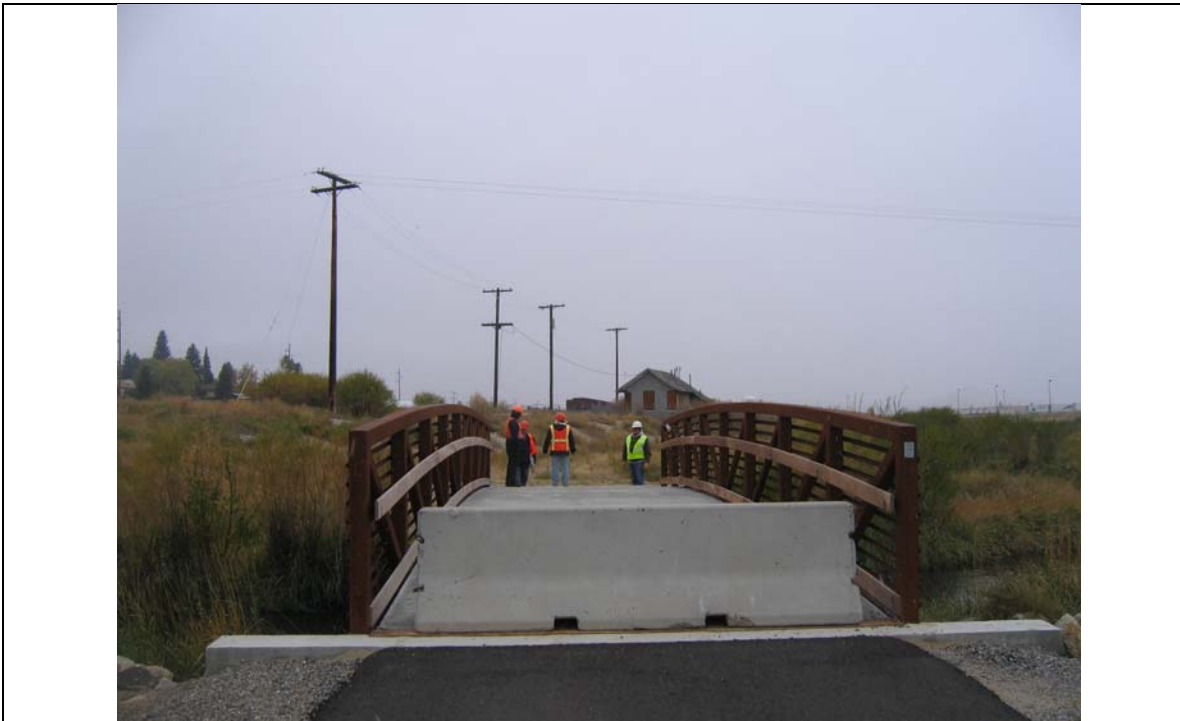
Photo 2. New bridge across Silver Bow Creek near Rocker OU. Trail will eventually pass at the toe of the repository.

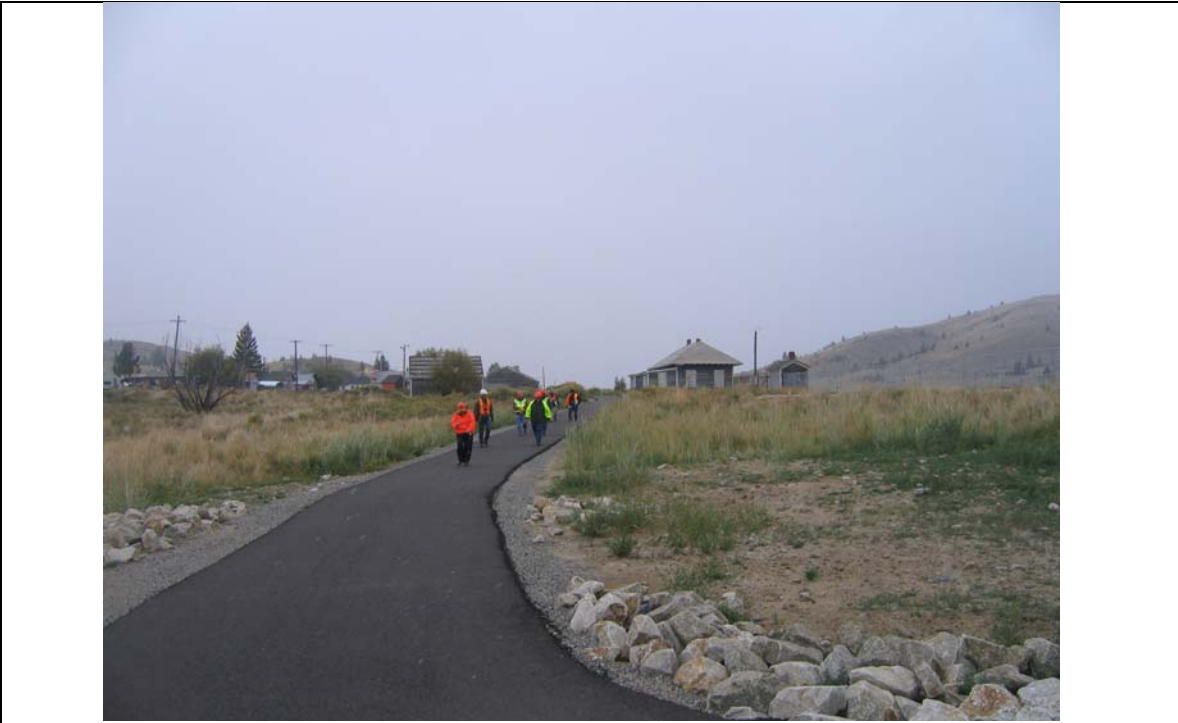
Photo 3. Silver Bow Creek Greenway trail (looking east)

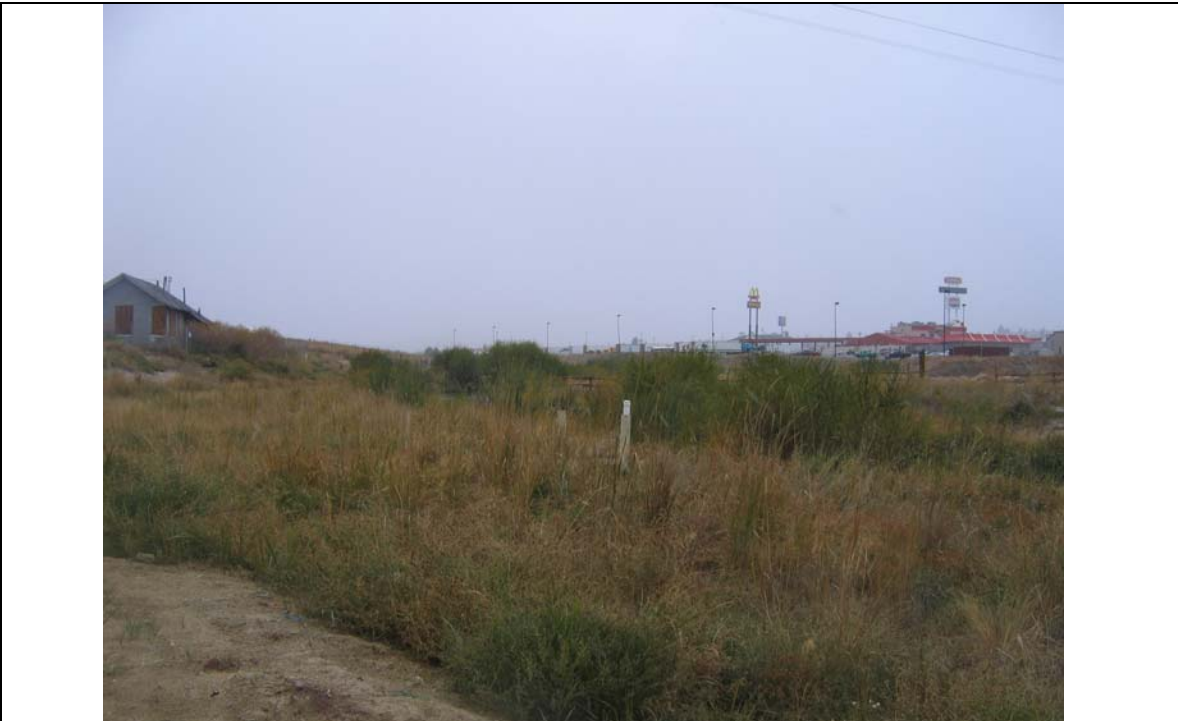
Photo 4. Monitoring wells with evidence of frost heaving. Town pump visible in background.

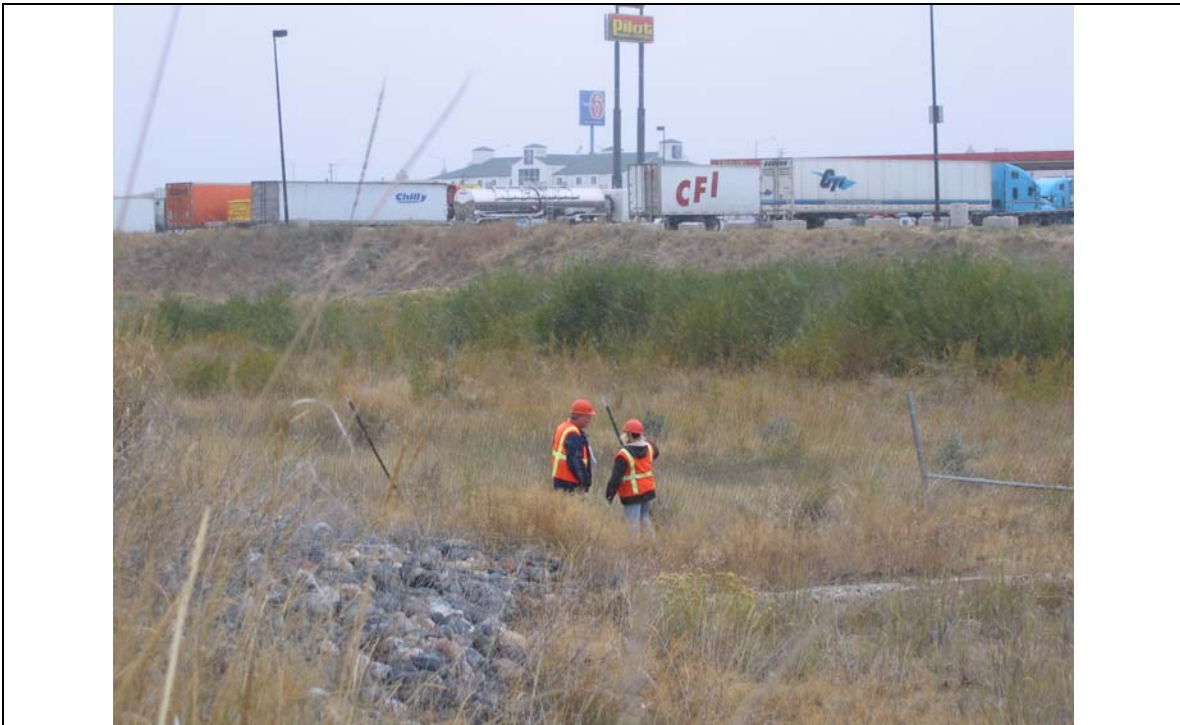
Photo 5. Damaged fencing along edge of repository. Rip rap visible in foreground.

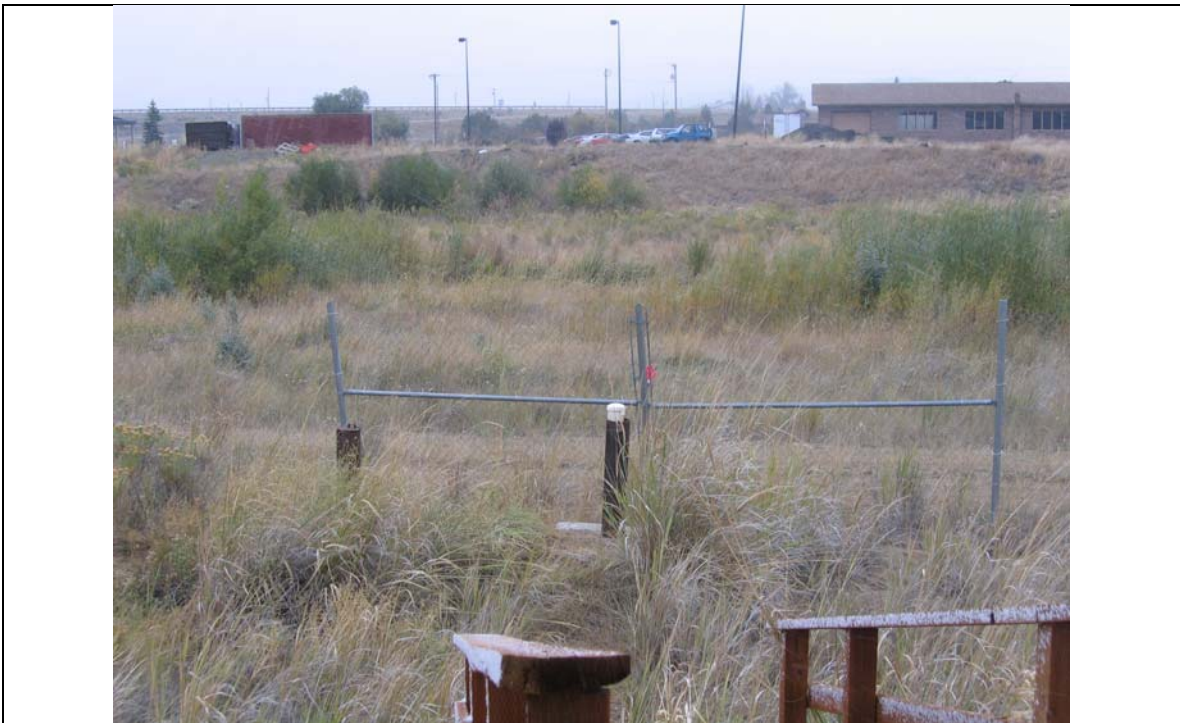
Photo 6. Damaged gate and well with frost heaving.

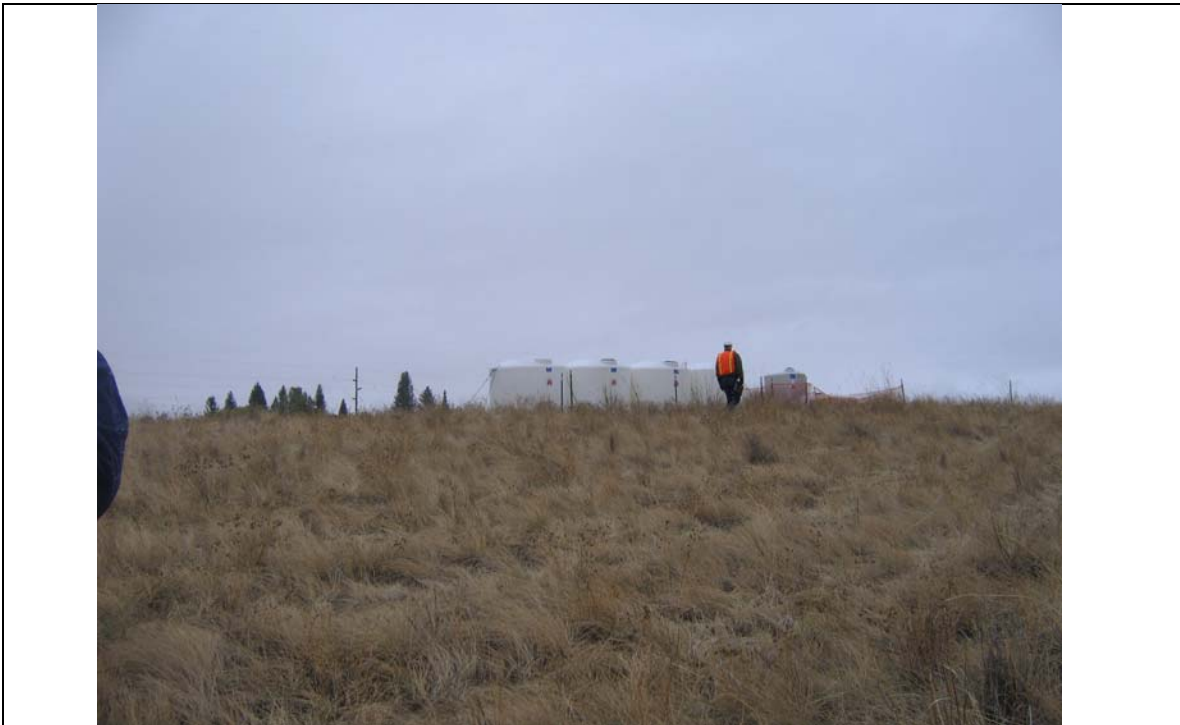
Photo 7. Empty tanks (used for previous groundwater dosing)

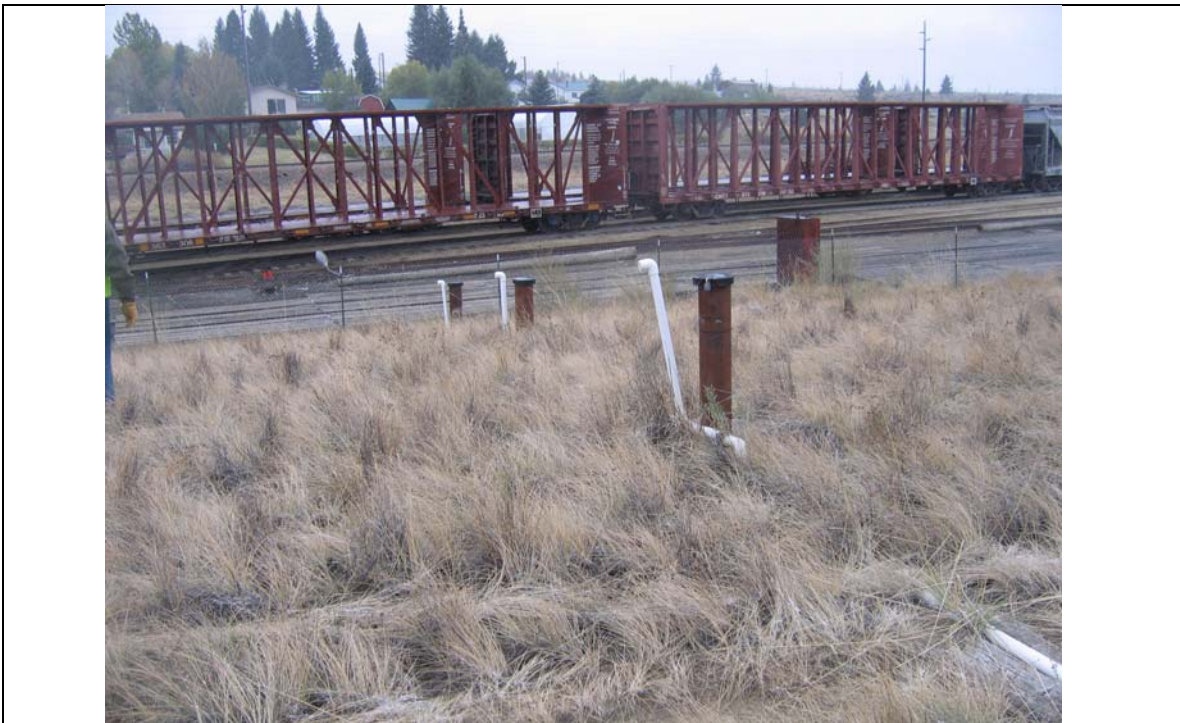
Photo 8. Array of injection wells remaining from groundwater dosing.

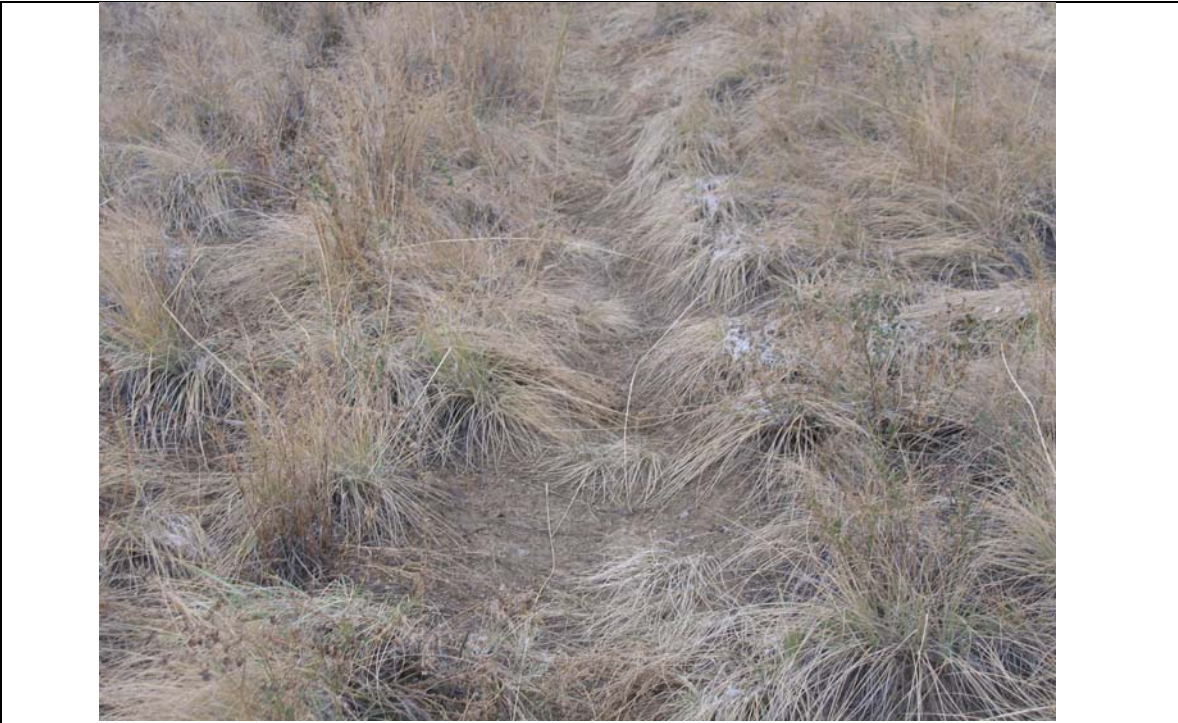
Photo 9. Tire ruts from repeated driving on repository cap.

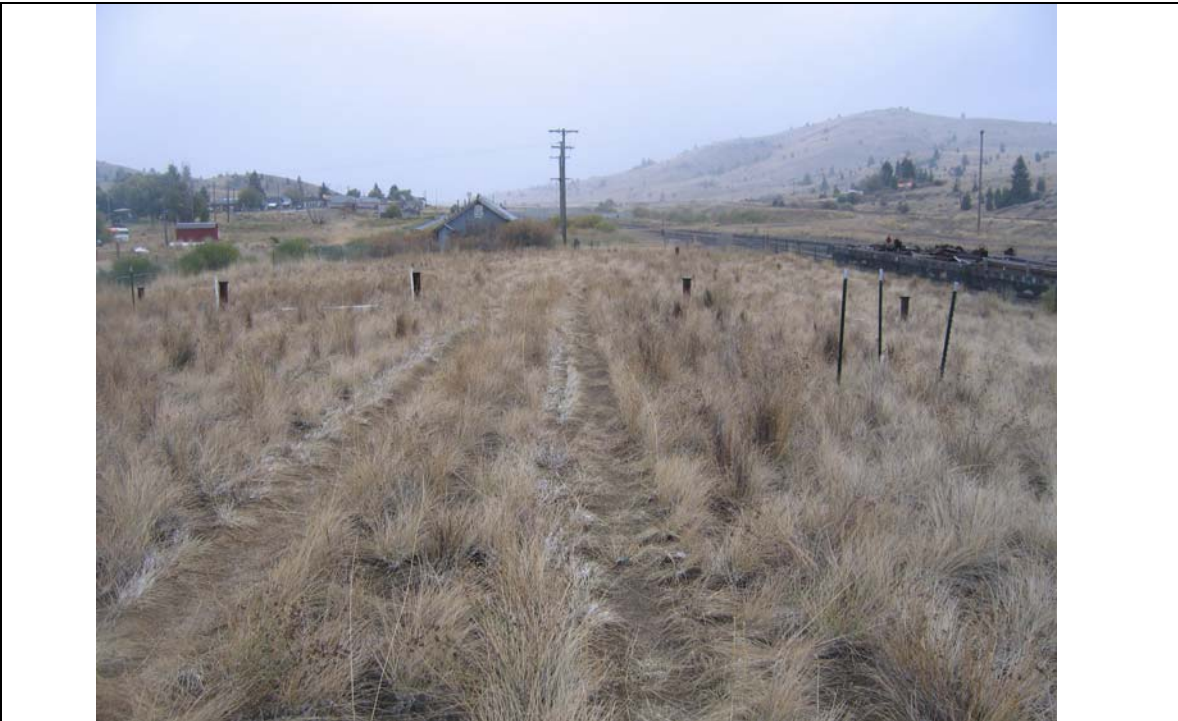
Photo 10. Tire ruts on repository cap.
