Appendix A

Site Inspection Photographs

Photographs Taken During Site Inspection: October 6, 2009

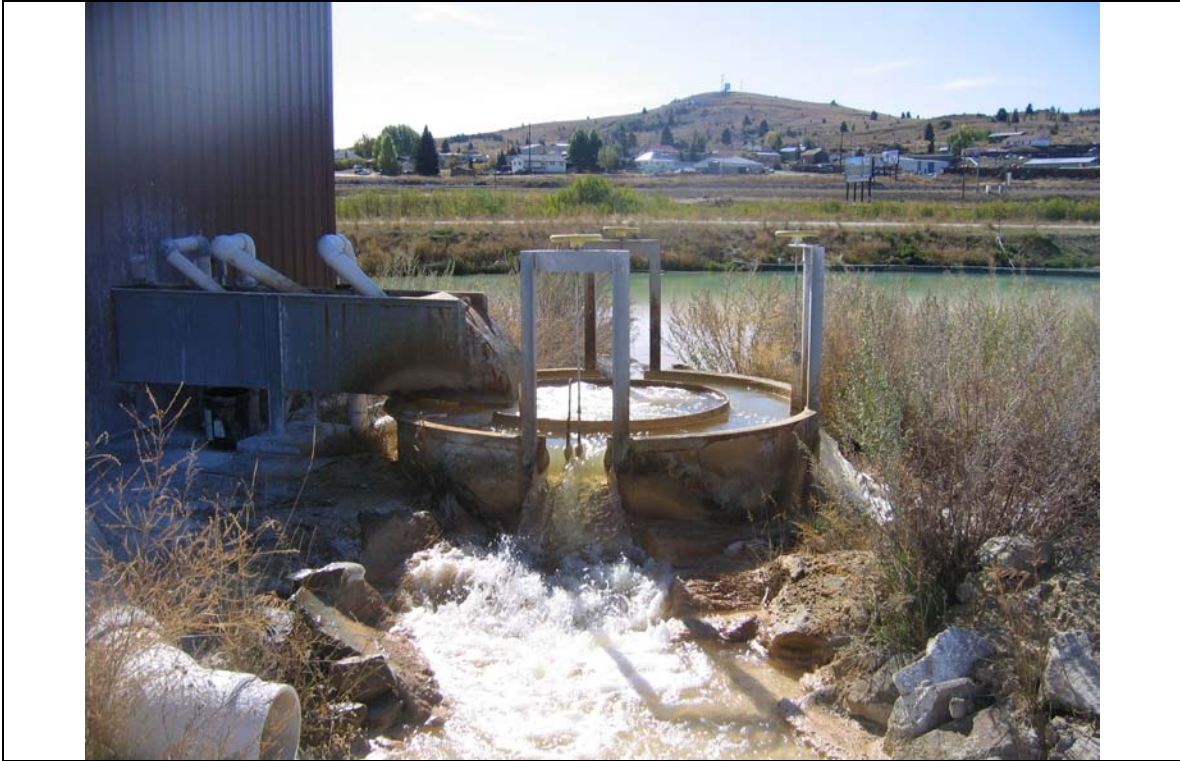
Photo 1. Lower Area One Flow Distributor

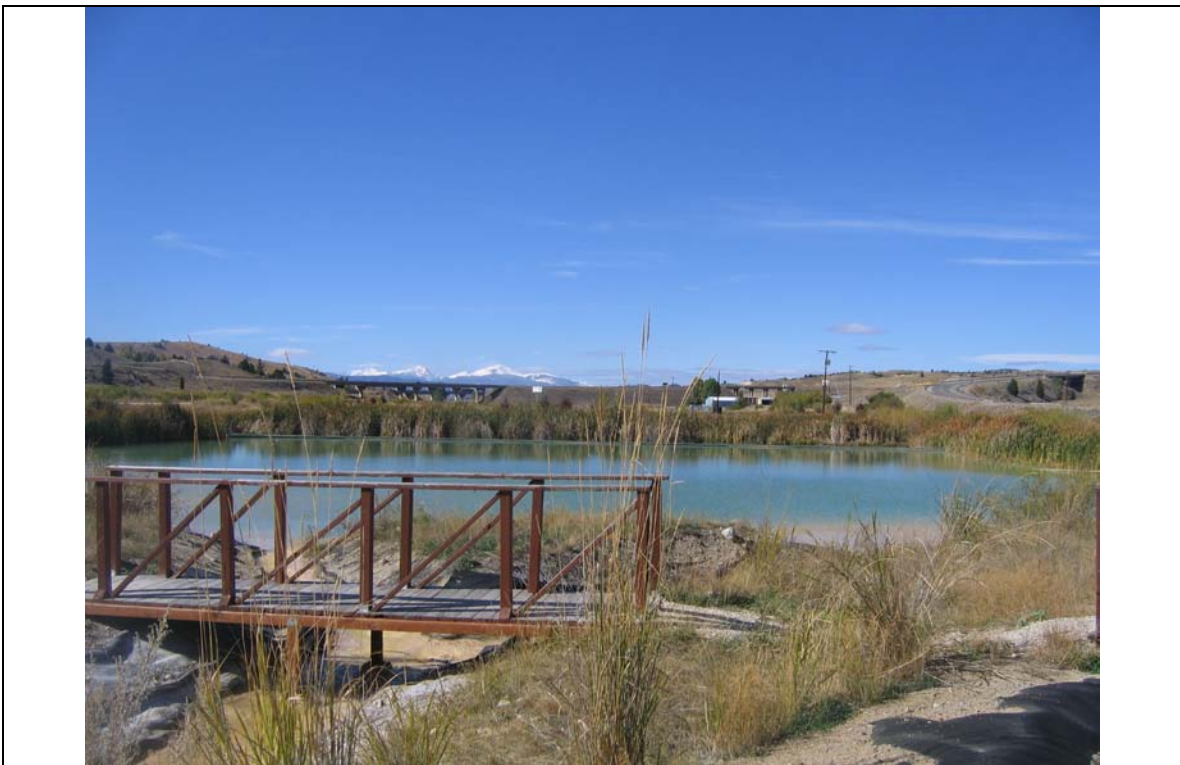
Photo 2. Lower Area One B1 Cell

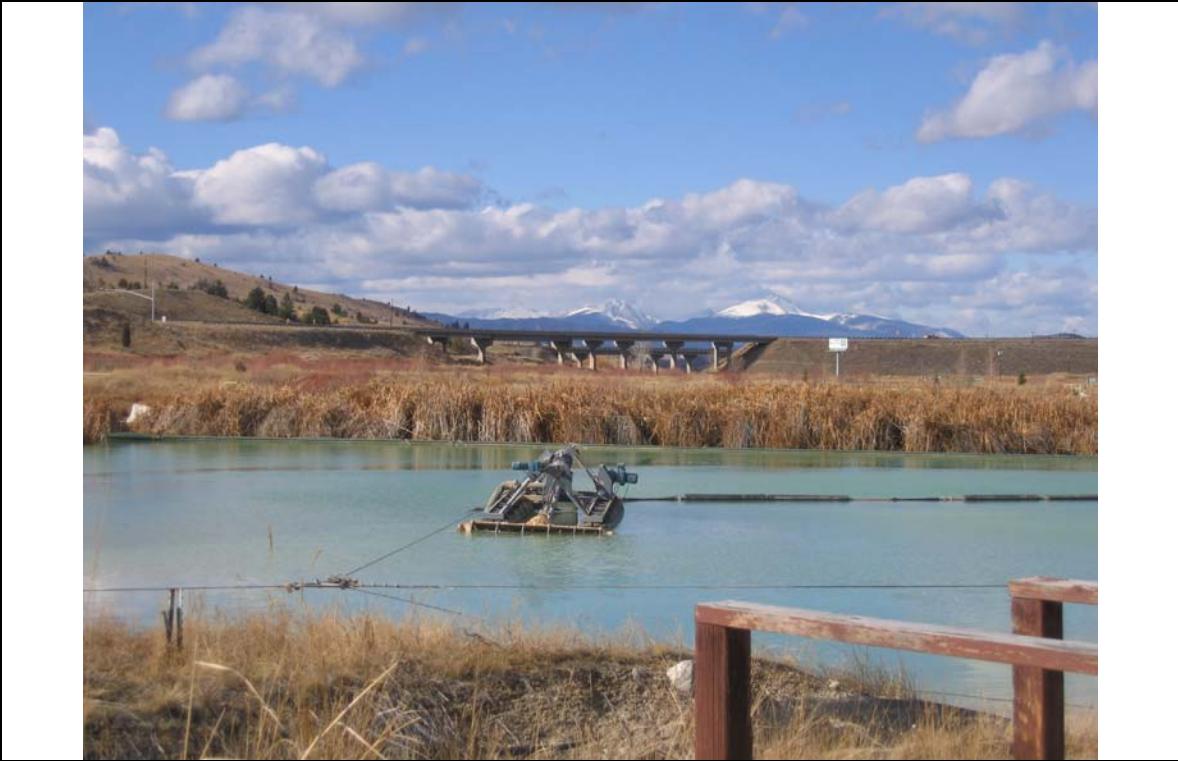
Photo 3. Lower Area One B1 Cell Sludge Dredging Barge

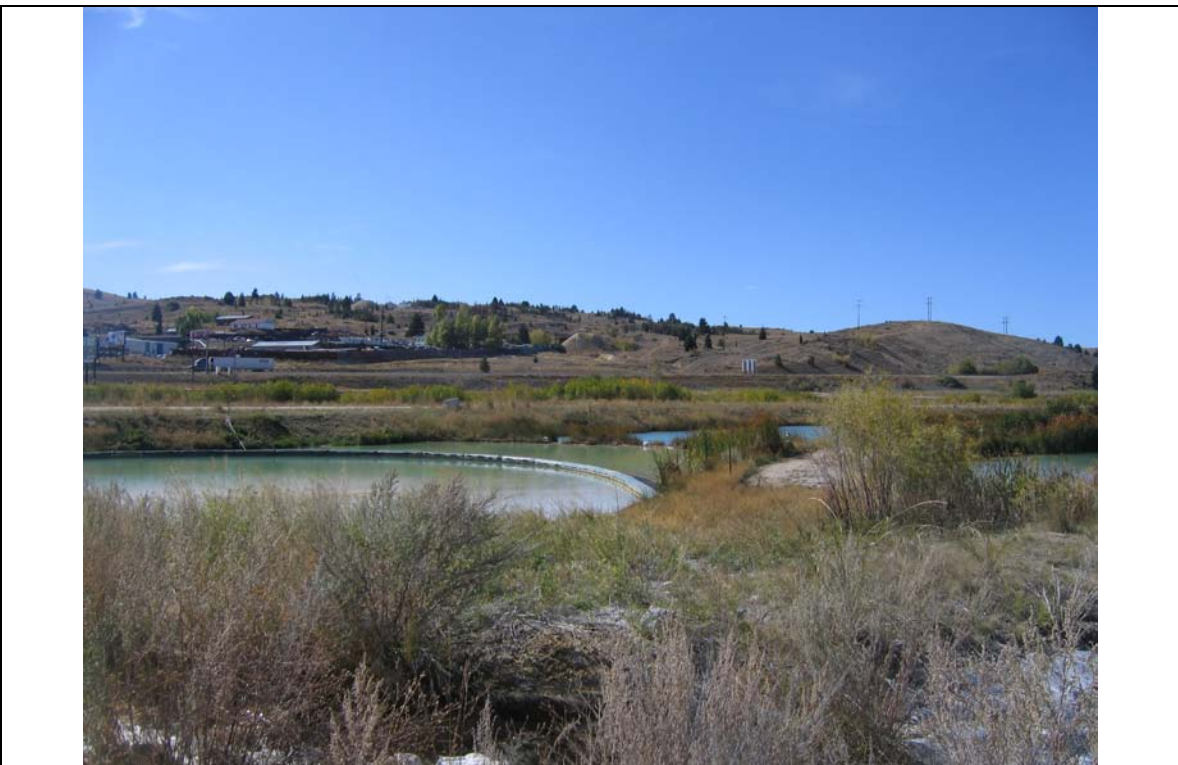
Photo 4. Lower Area One C1 Cell

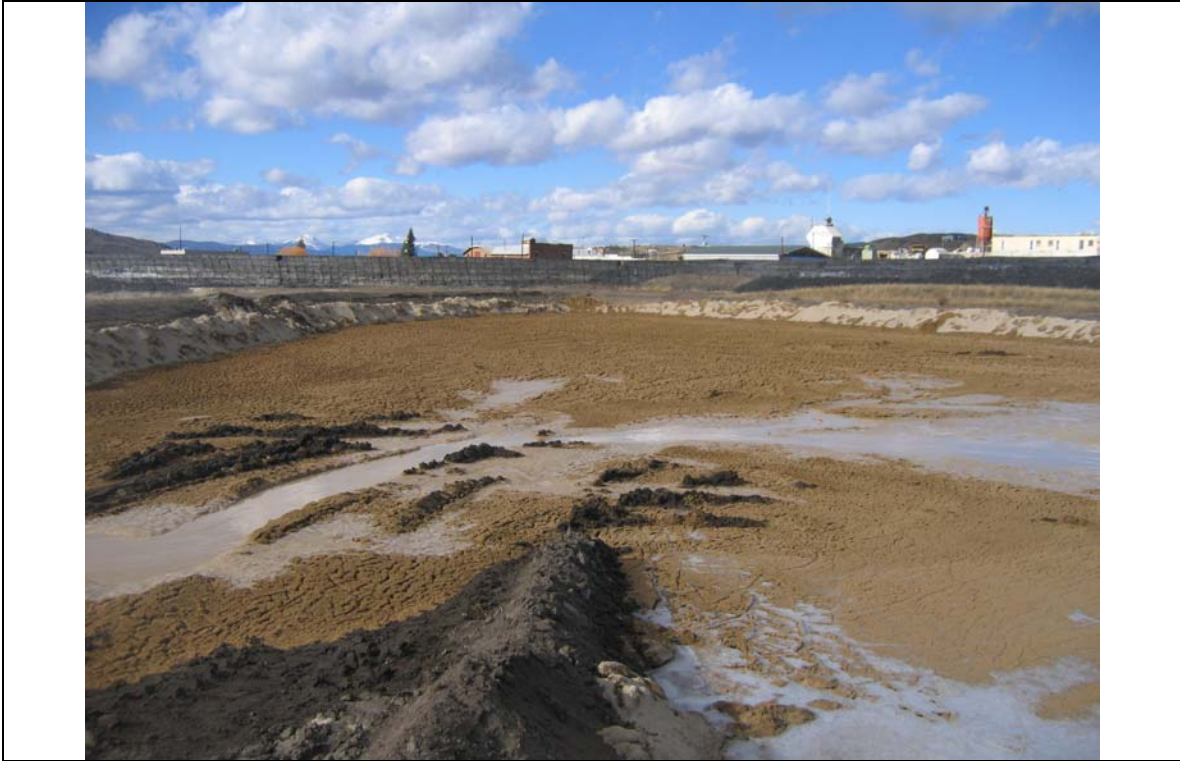
Photo 5. Sludge Drying Bed at Lower Area One

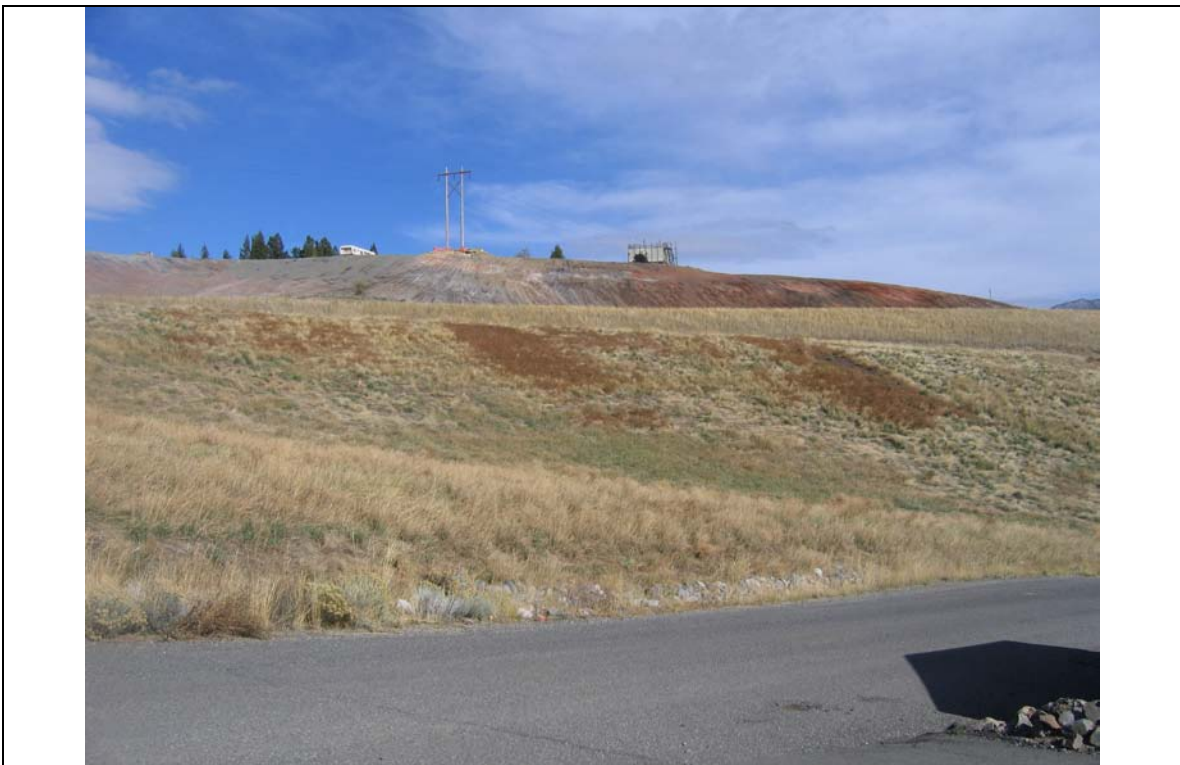
Photo 6. Little Minah Cap, Active Reclamation of Mountain Con mine dump in the background.

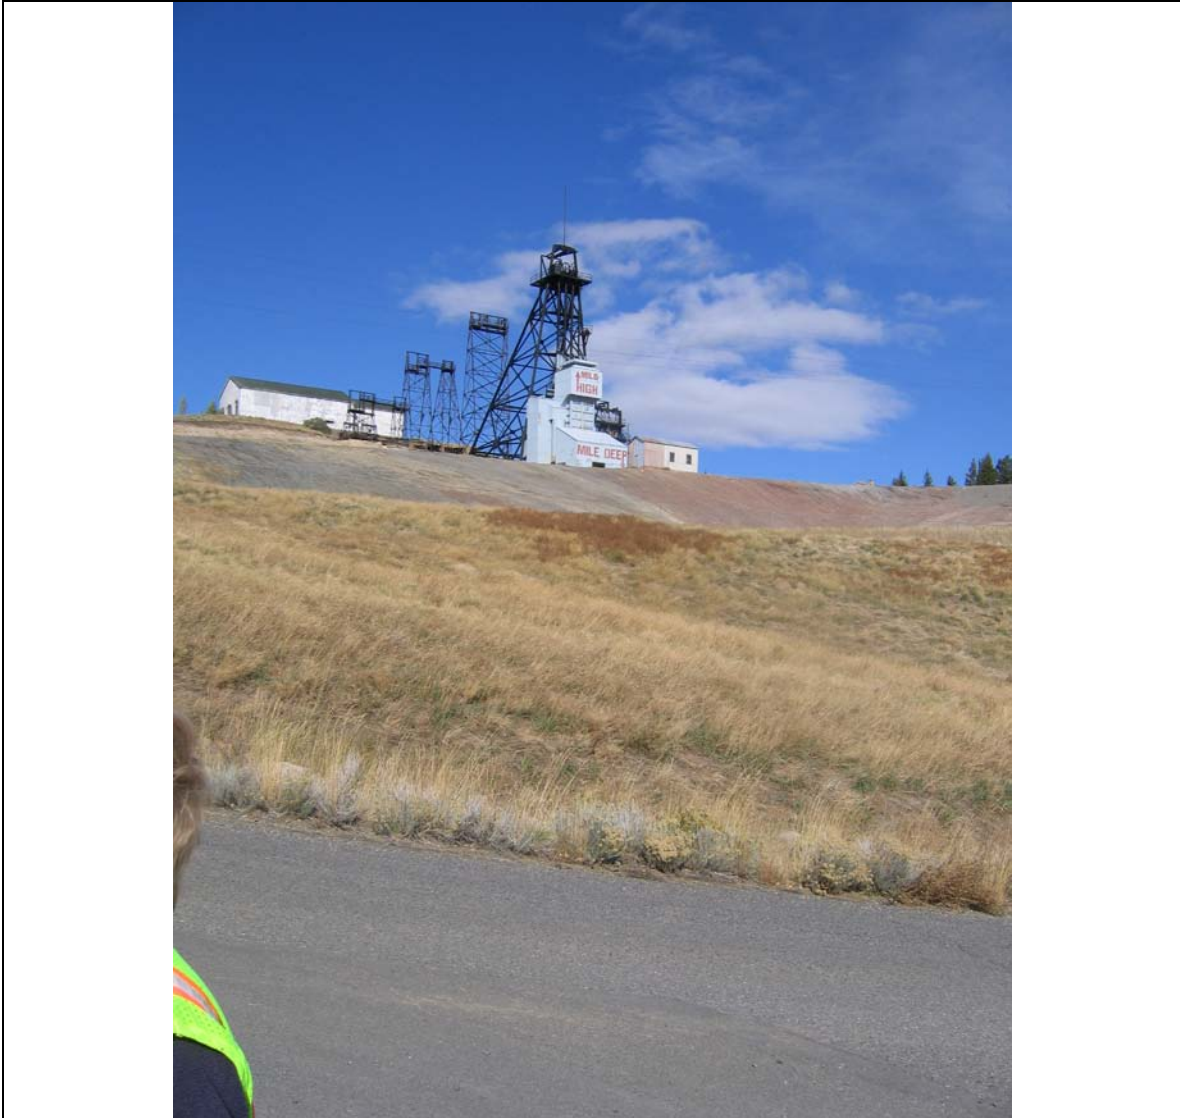
Photo 7. Mountain Con headframe and recontoured waste dump with Little Minah dump reclamation in the foreground.

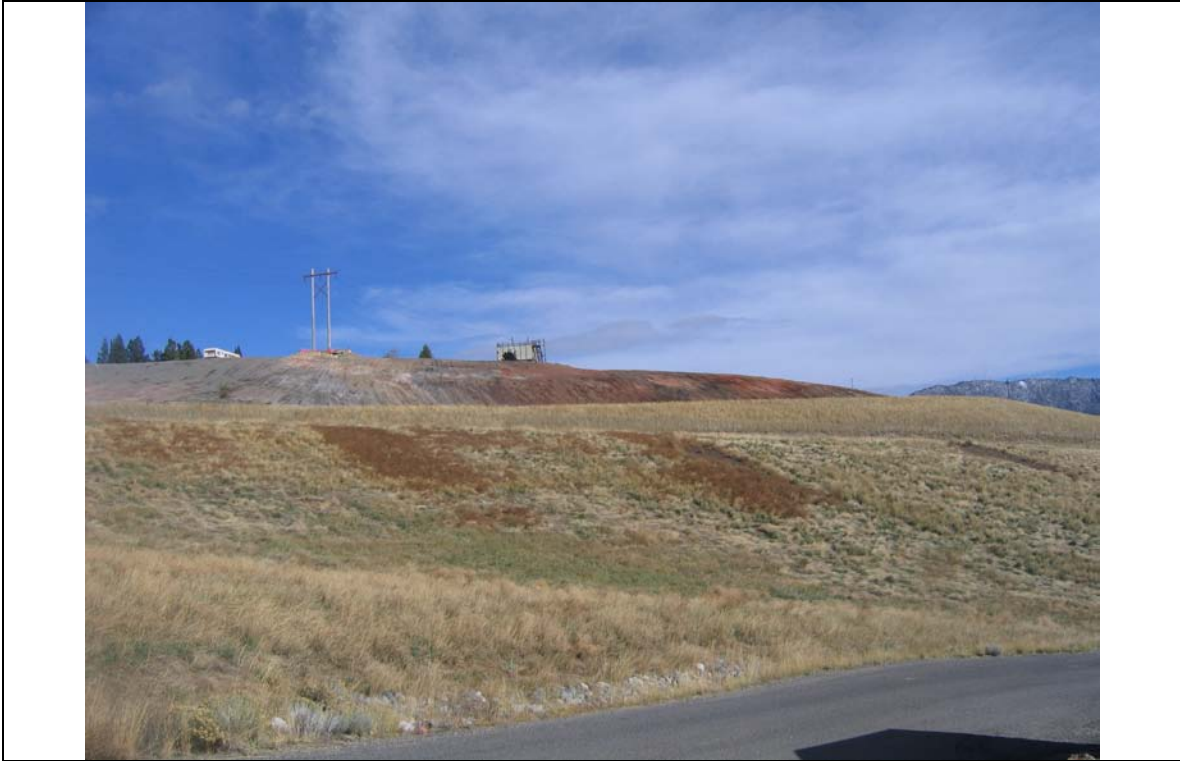
Photo 8. Little Minah Dump Reclamation, barren or weedy areas requiring vegetation improvement.

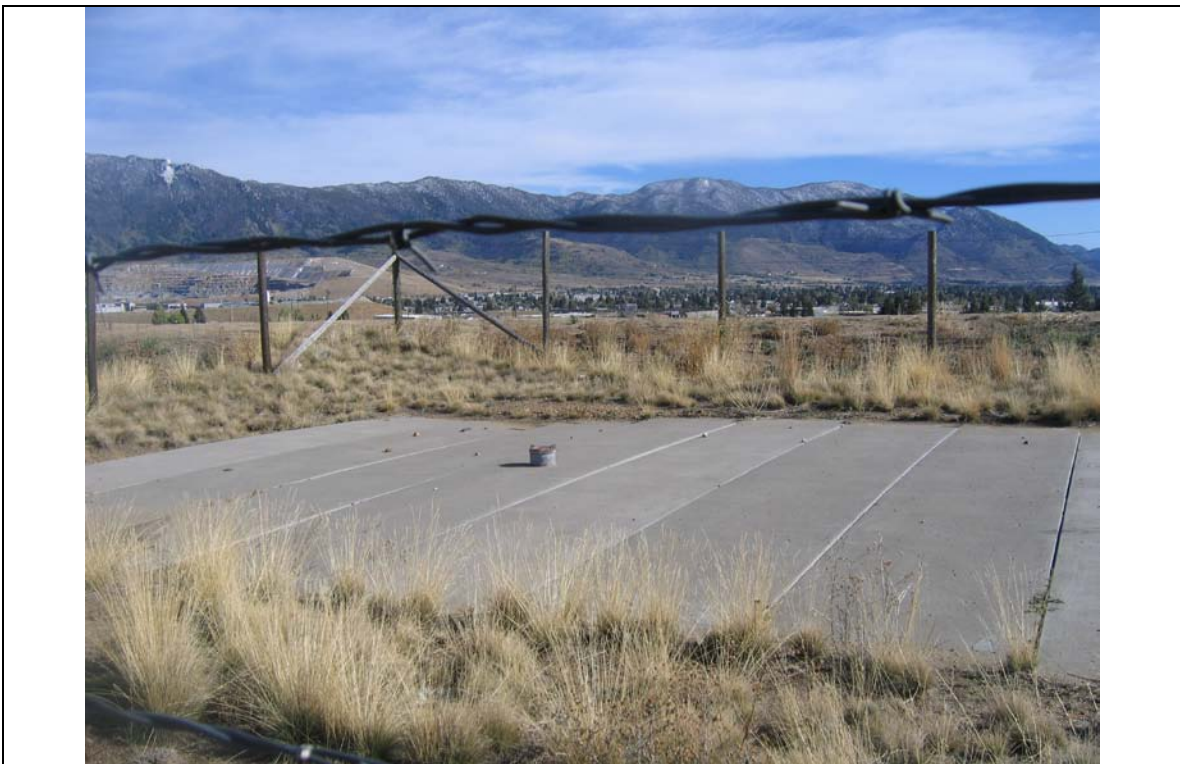
Photo 9. Concrete Cover over the Otisco Shaft

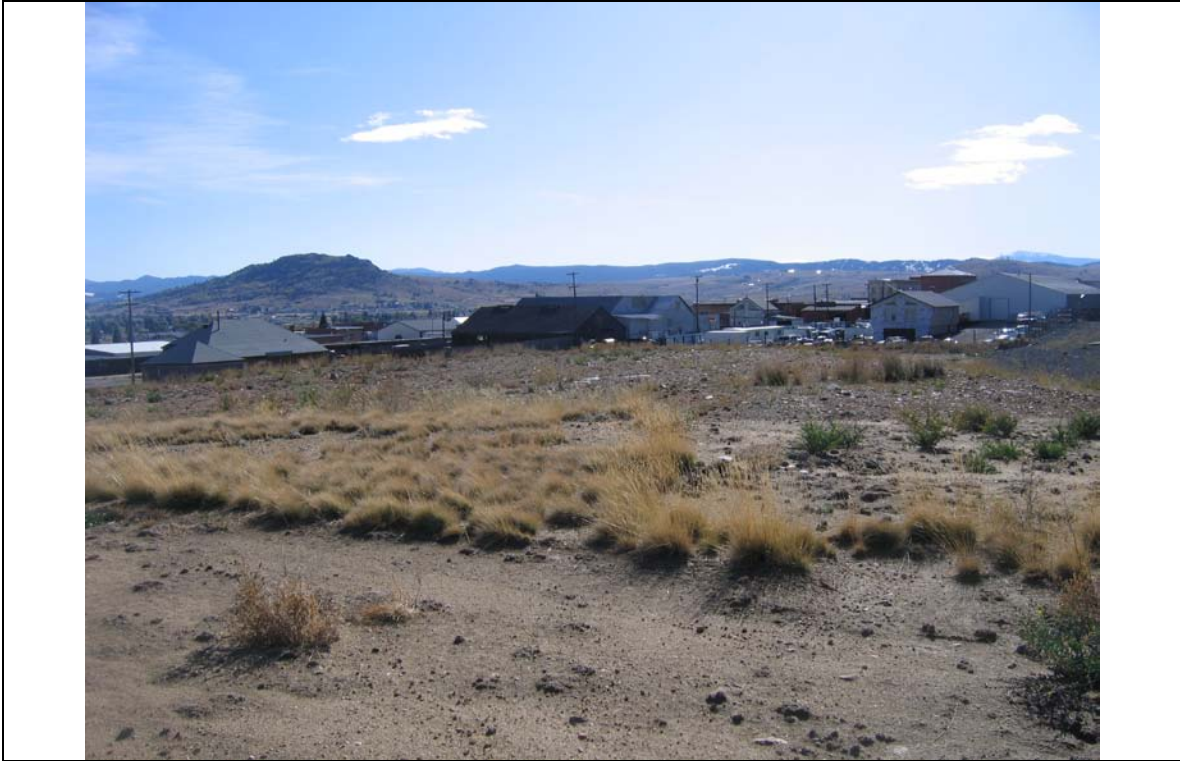
Photo 10. Otisco cap showing barren areas and exposed mine waste. Site was reclaimed prior to establishment of soil requirements for vegetative growth.

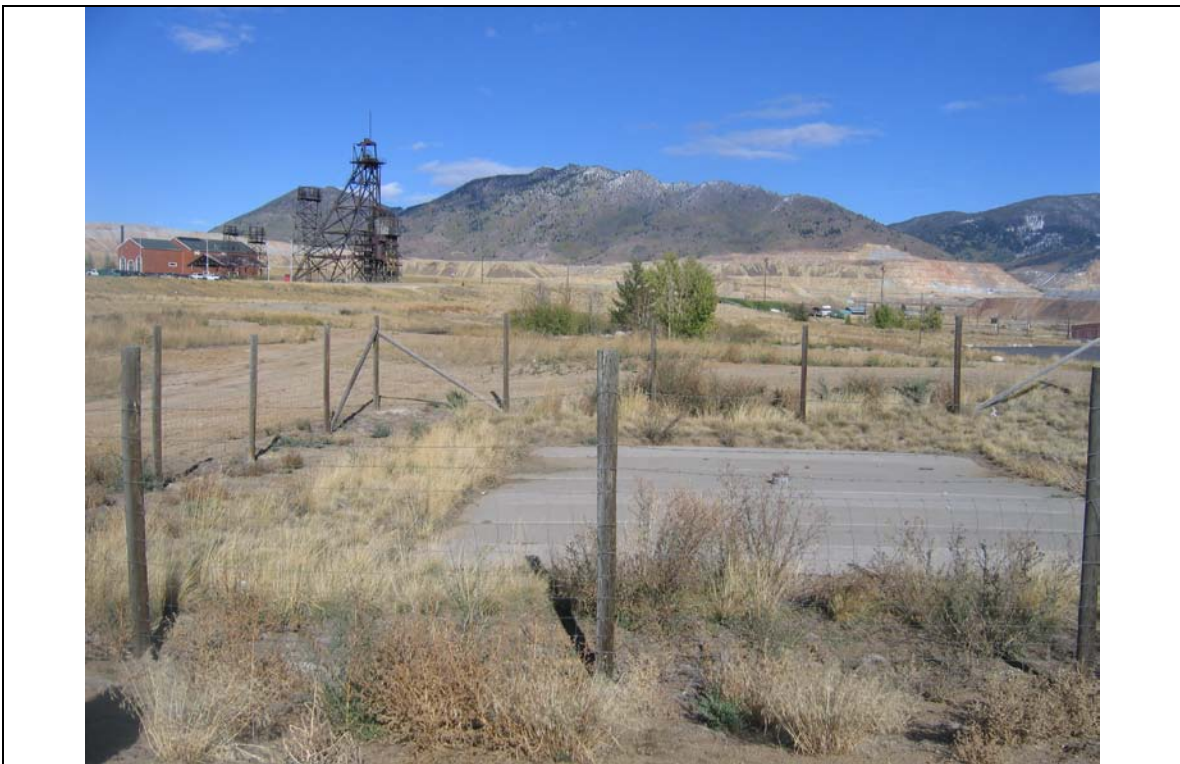
Photo 11. Looking Northeast over the Otisco shaft cover.

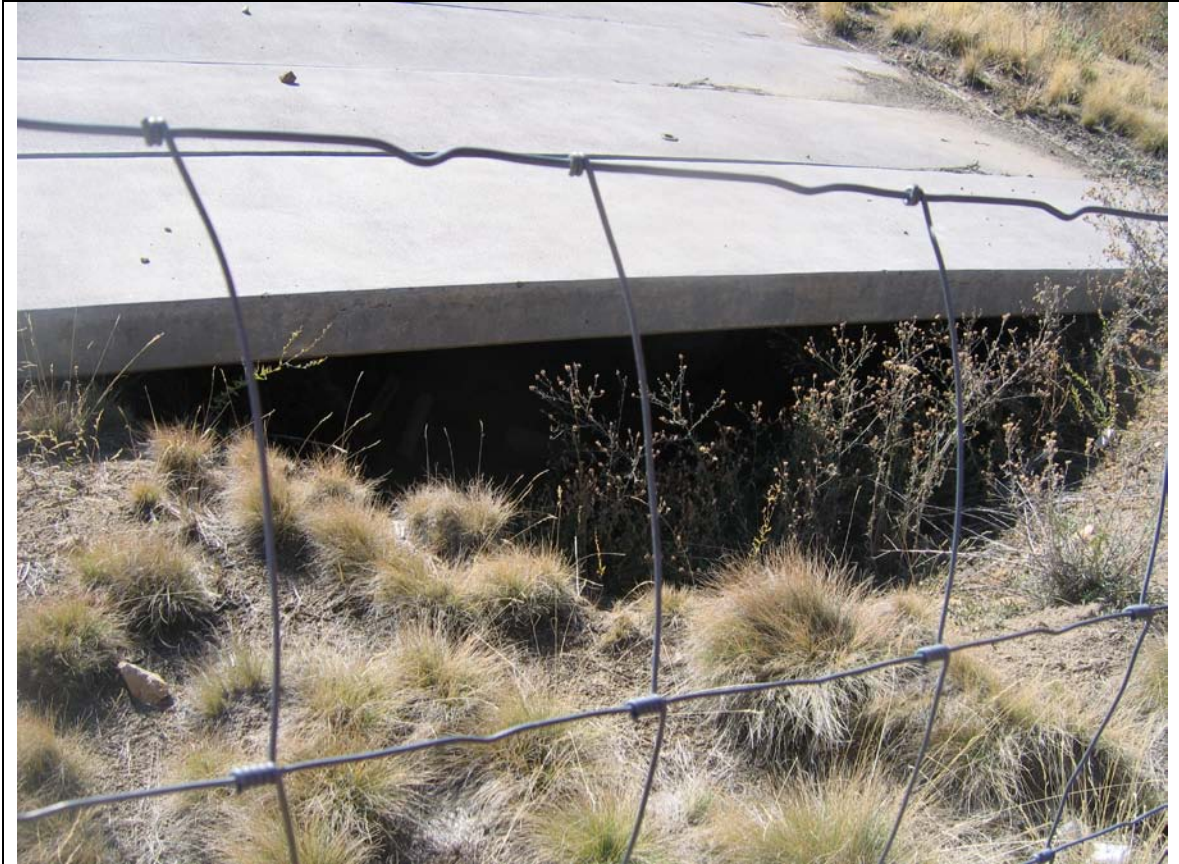
Photo 12. Otisco Shaft cover compromised. (Note that a physical hazard such as a mine shaft is not addressed under CERCLA.)

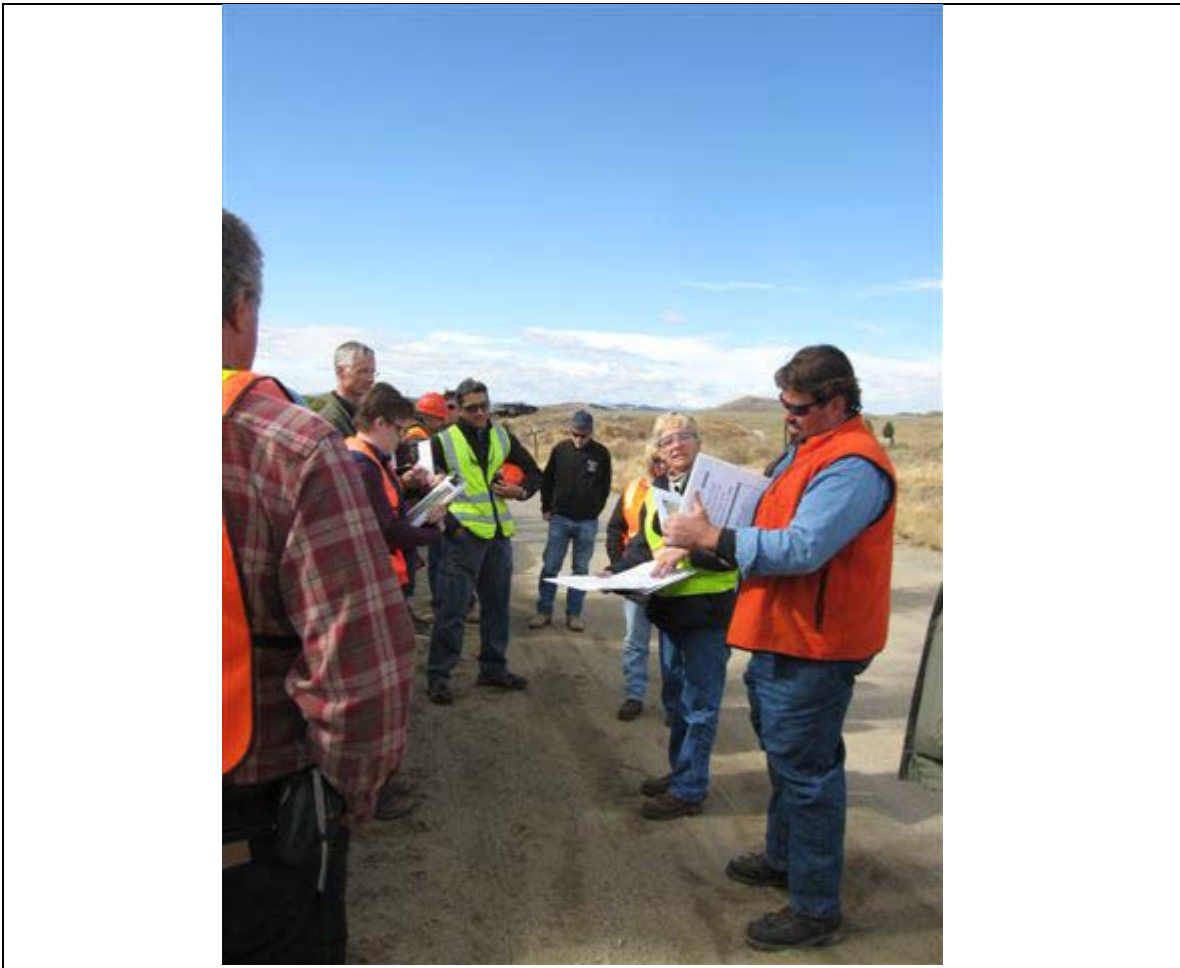
Photo 13. Site inspection tour group at the Minnie Irvine dump (in background).
