# Photographs

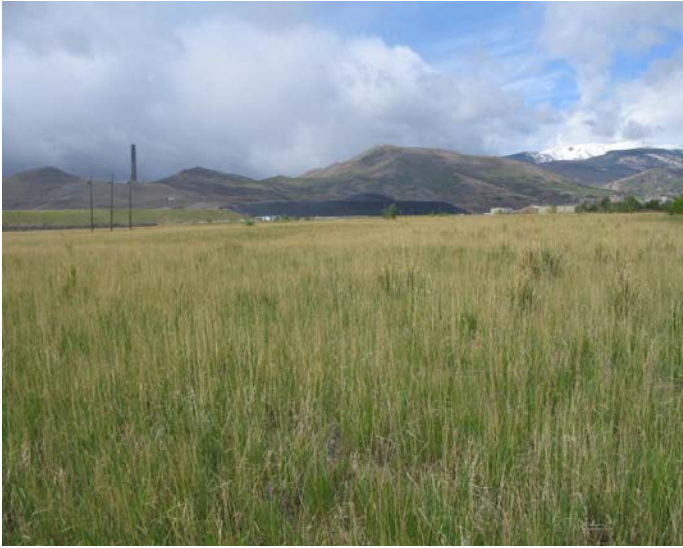
Photograph 5719. Abundant perennial grass cover in the 2007 Type A coversoil area south of Warm Springs Creek. Subarea 6 (Drag Strip) in the OW/EADA OU.

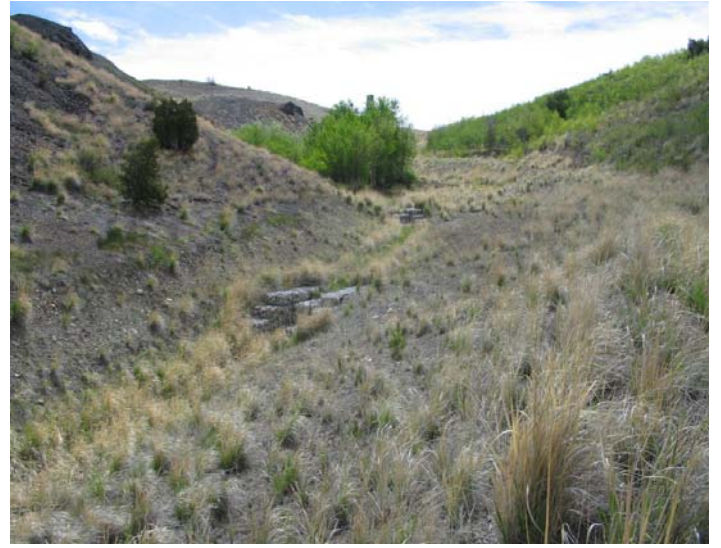
Photograph 5722. Some open ground but good overall perennial vegetation cover in Nazer Gulch. Gabion rock dropped structures are intact and functional. Work conducted under RDU 3 – Anaconda Ponds WMA.

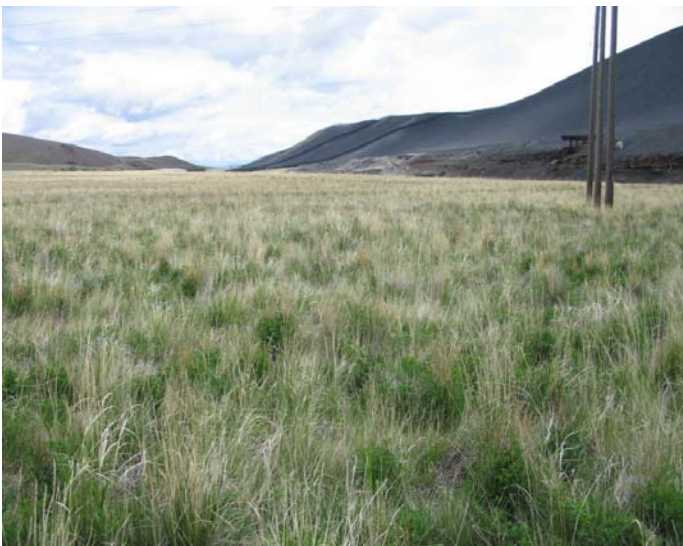
Photograph 5730. Well established vegetation with relatively high cover, little to no soil movement, no bare areas, and low weed cover in the East Anaconda Yards. Subarea 5 of the OW/EADA OU.

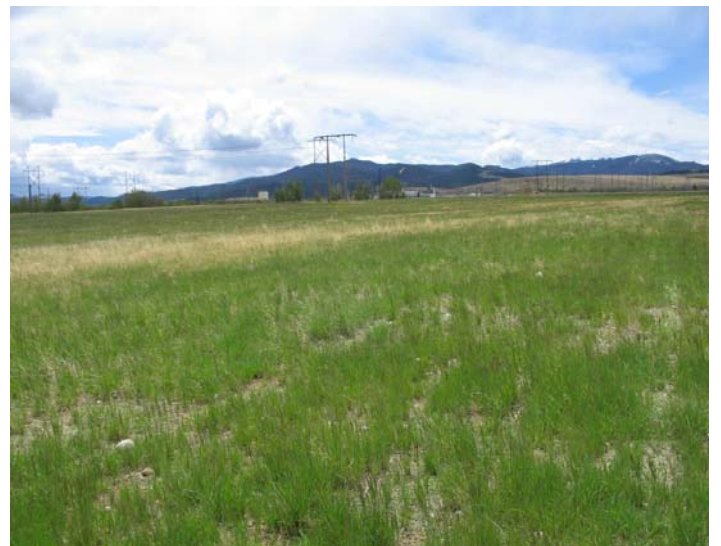
Photograph 5735. Good seed germination on 2009-seeded A1 Lumber site. Subarea 3 (Industrial Area) of the OW/EADA OU.

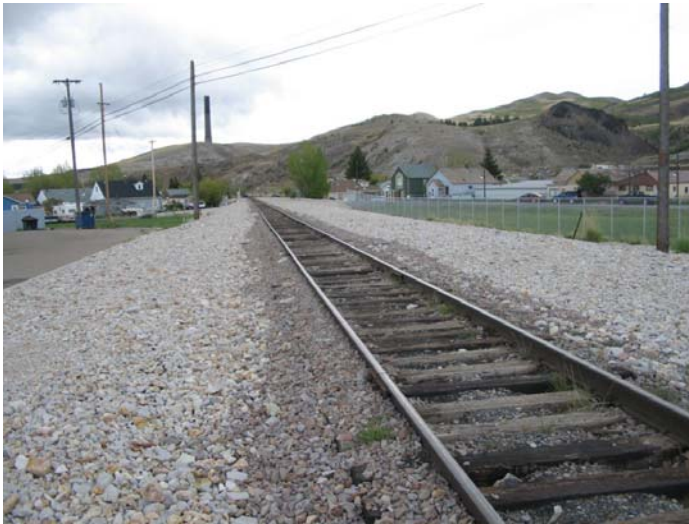
Photograph 5739. Rock cap and retaining wall in Anaconda to prevent contaminated sediment from getting onto the city street. RDU 5 – Active Railroad/Blue Lagoon. (Community Soils OU remedy)

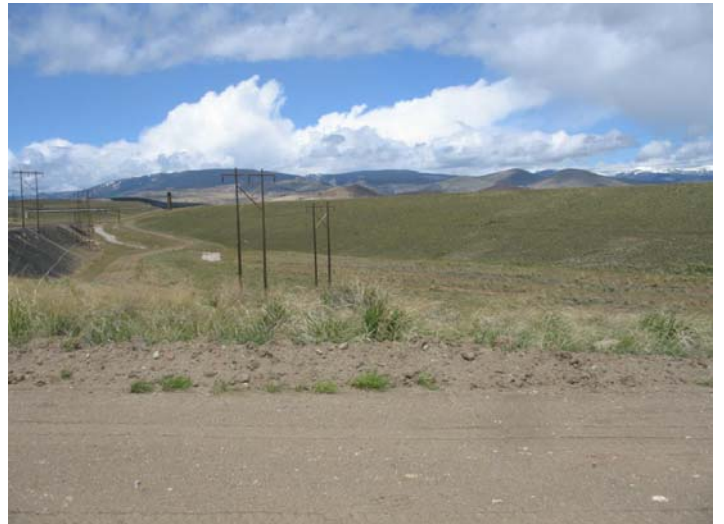
Photograph 5743. Typical view of a well vegetated Dike Face on the Anaconda Ponds (area is the south-west facing dike). RDU 4 - Anaconda Ponds WMA.

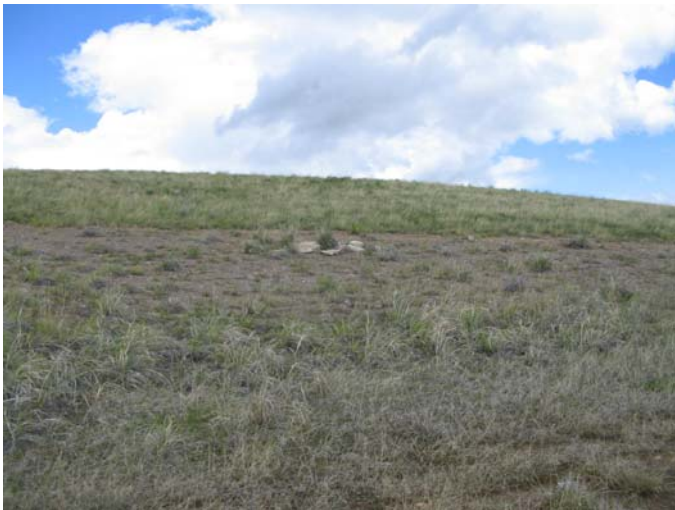
Photograph 5757. Sparsely vegetated portion of the Flue Dust repository cap. RDU 14 - Smelter Hill Facilities Area WMA.

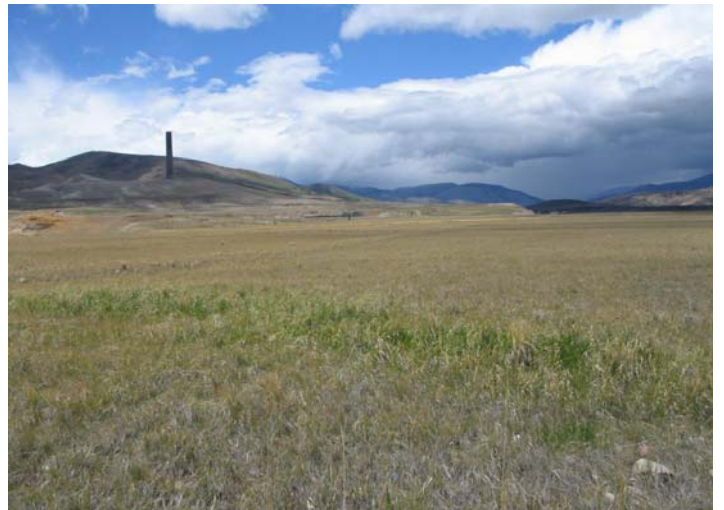
Photograph 5758. Typical view of the well vegetated surface of the ponds. RDU 4 - Anaconda Ponds WMA.

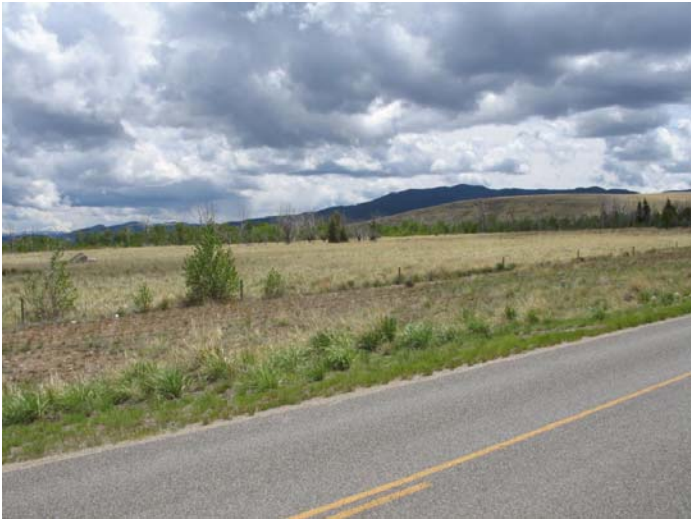
Photograph 5762. Well-vegetated area at the former Mill Creek townsite. Area now part of Subarea 5 – East Anaconda Yards/Aspen Hills of the OW/EADA OU.

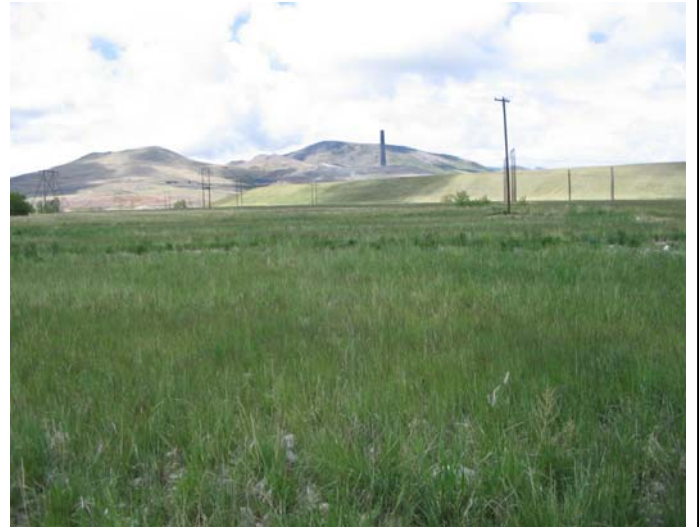
Photograph 5775. Stripped and in-situ treated area with abundant perennial plant growth. RDU 6 – South Opportunity.

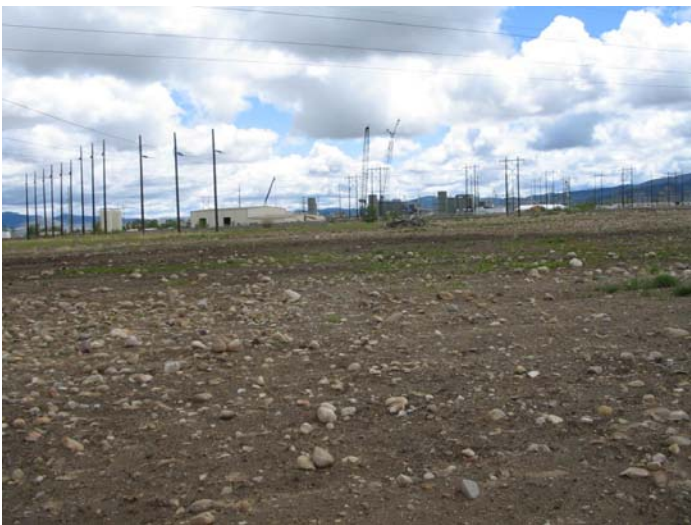
Photograph 5777. In-situ treated (non-stripped) area with virtually no plant growth. RDU 6 – South Opportunity.

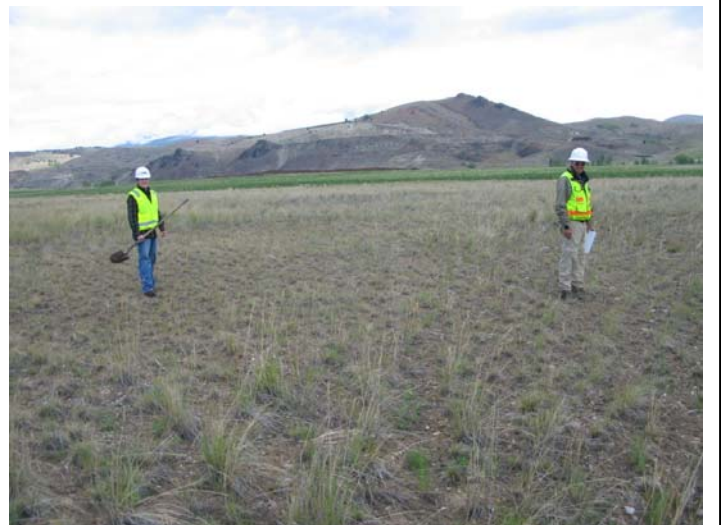
Photograph 5782. Low vegetation cover on Type B material (foreground) and greener, well-vegetated Type A cap (background). Subarea 4 (Red Sands) of the OW/EADA OU.

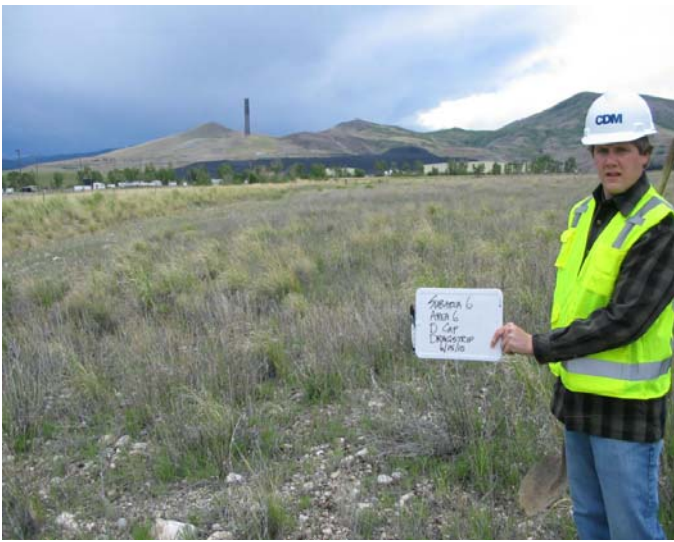
Photograph 5799. Poor perennial plant growth and abundant knapweed on the in-situ treated area. Subarea 6 (Drag Strip) in the OW/EADA OU.

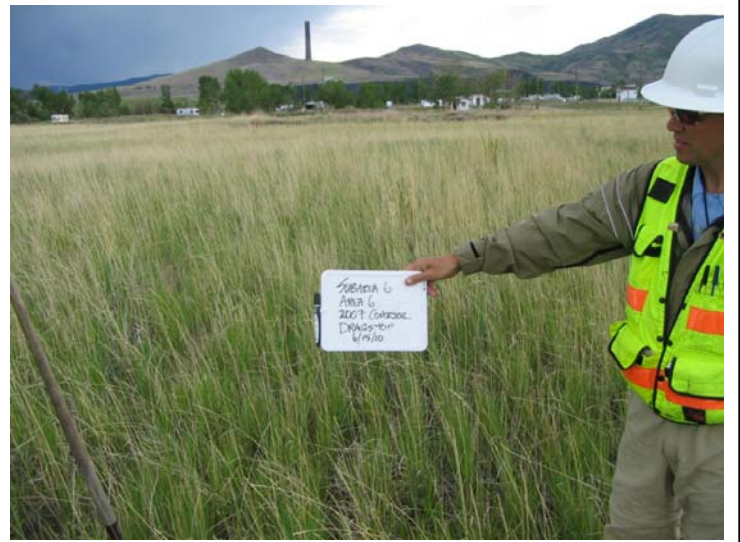
Photograph 5801. Well vegetated perennial grass growth on the 2007 coversoiled area. Subarea 6 (Drag Strip) in the OW/EADA OU.

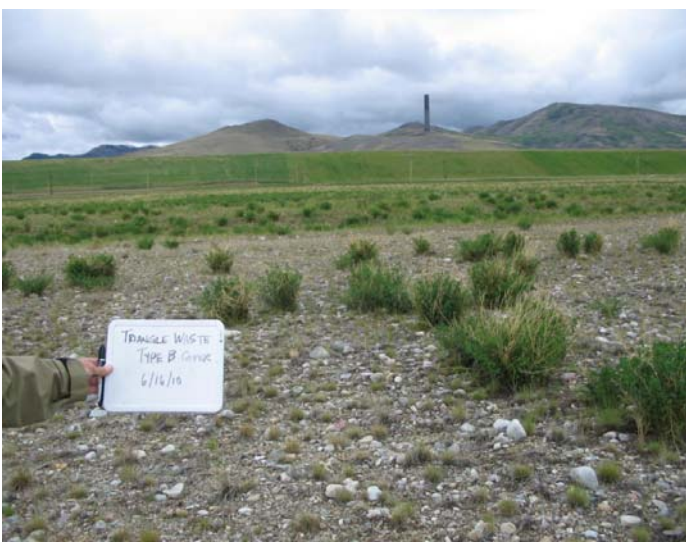
Photograph 5807. Sparse vegetation growth on very coarse Type B material in the Triangle Waste Area. RDU 8 – Opportunity Ponds WMA.

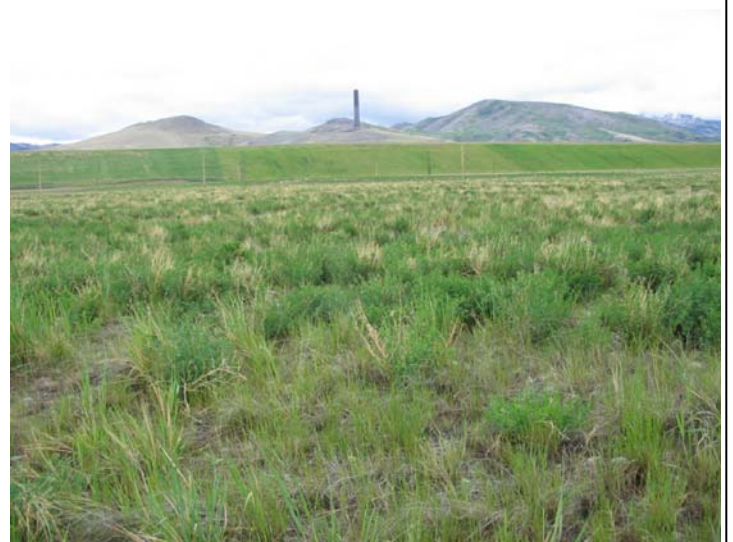
Photograph 5808. Well vegetated area on finer-textured Type B material within the Triangle Waste Area of RDU 8 Opportunity Ponds WMA.

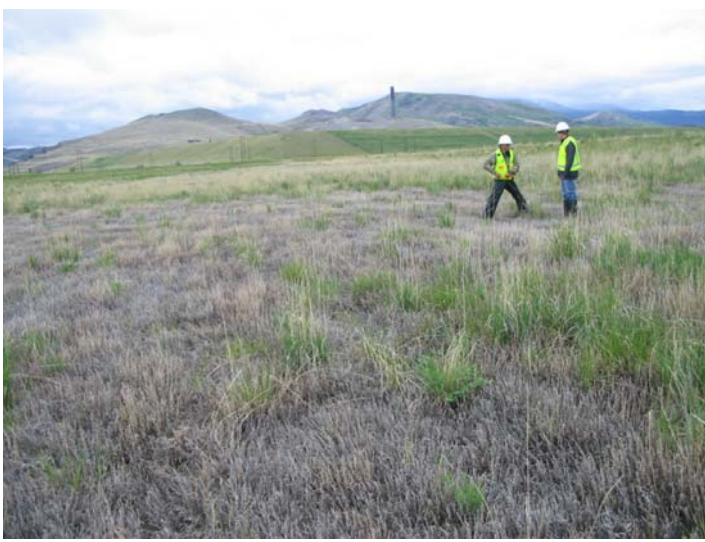
Photograph 5812. A9-4 Cell (RDU 8 – Opportunity Ponds WMA) showing areas devoid of perennial grasses and dominated by Kochia.

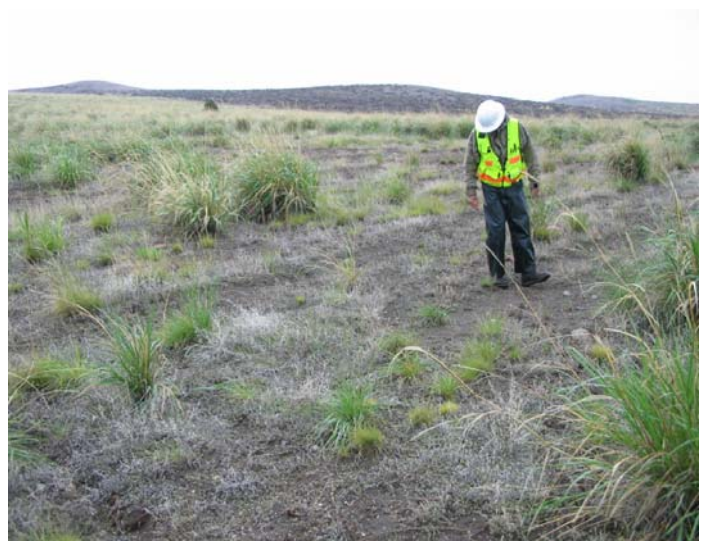
Photograph 5813. Yellow sheep fescue plants under stress in sparsely vegetated area of the 2002/03 Moto Cross Demonstration Areas. RDU 1 - Stucky Ridge.

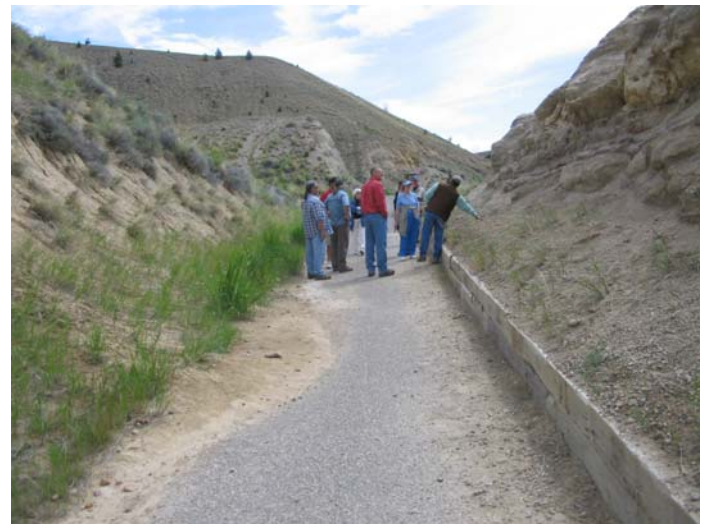
Photograph 5834. Sediment discharging onto the historic trail.

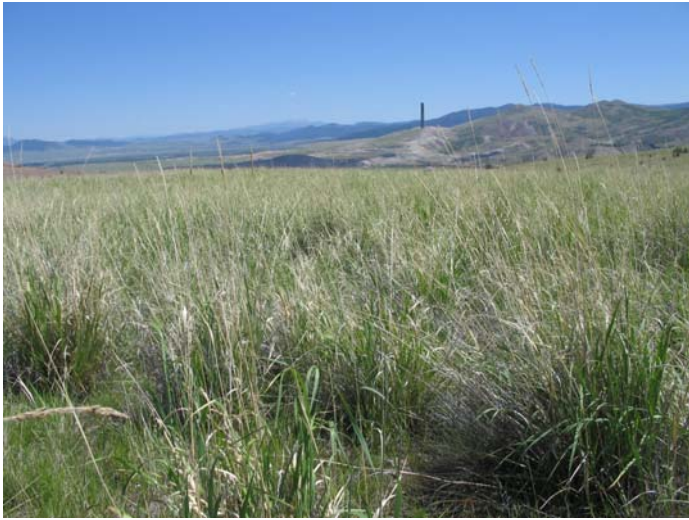
Photograph 5864. Abundant Great Basin wildrye growing in the Tillage Demonstration plots. RDU 1 – Stucky Ridge.
