Appendix A

Site Inspection Photographs

Photographs Taken During Site Inspection: October 7, 2009

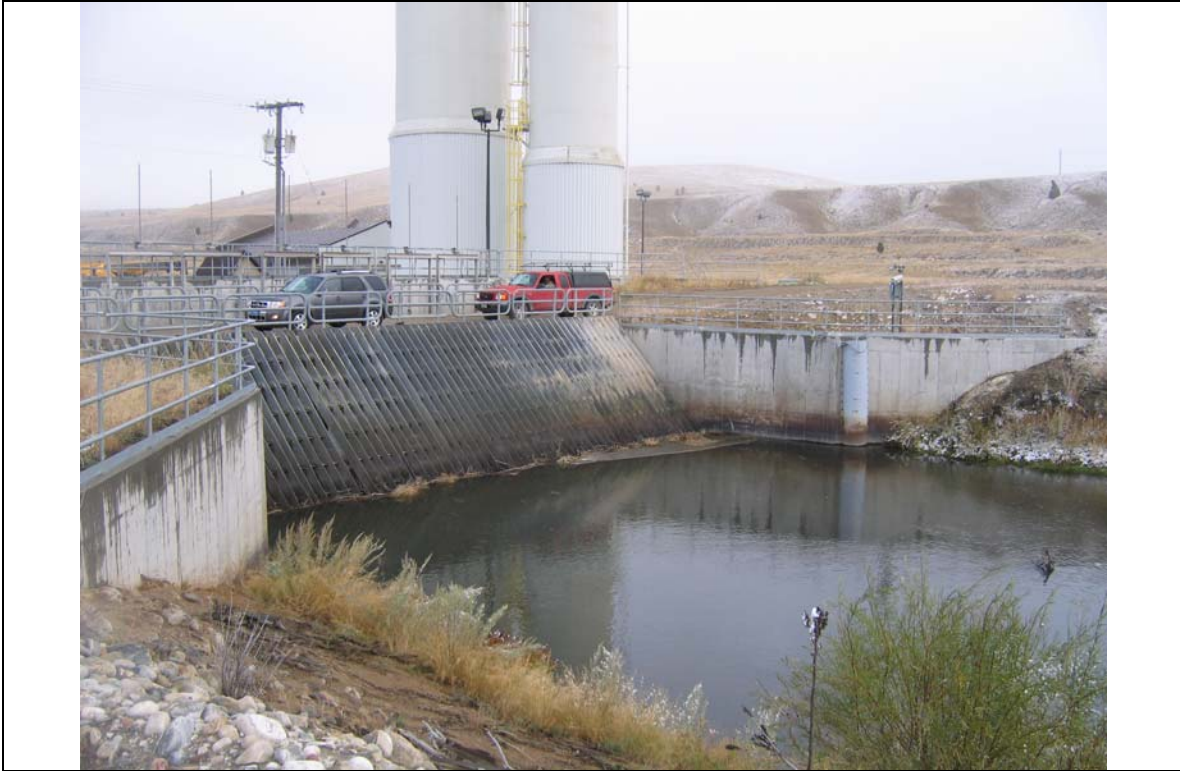
Photo 1. Silver Bow Creek entering the WSP hydraulic control structure and trash racks. Lime silos in background center.

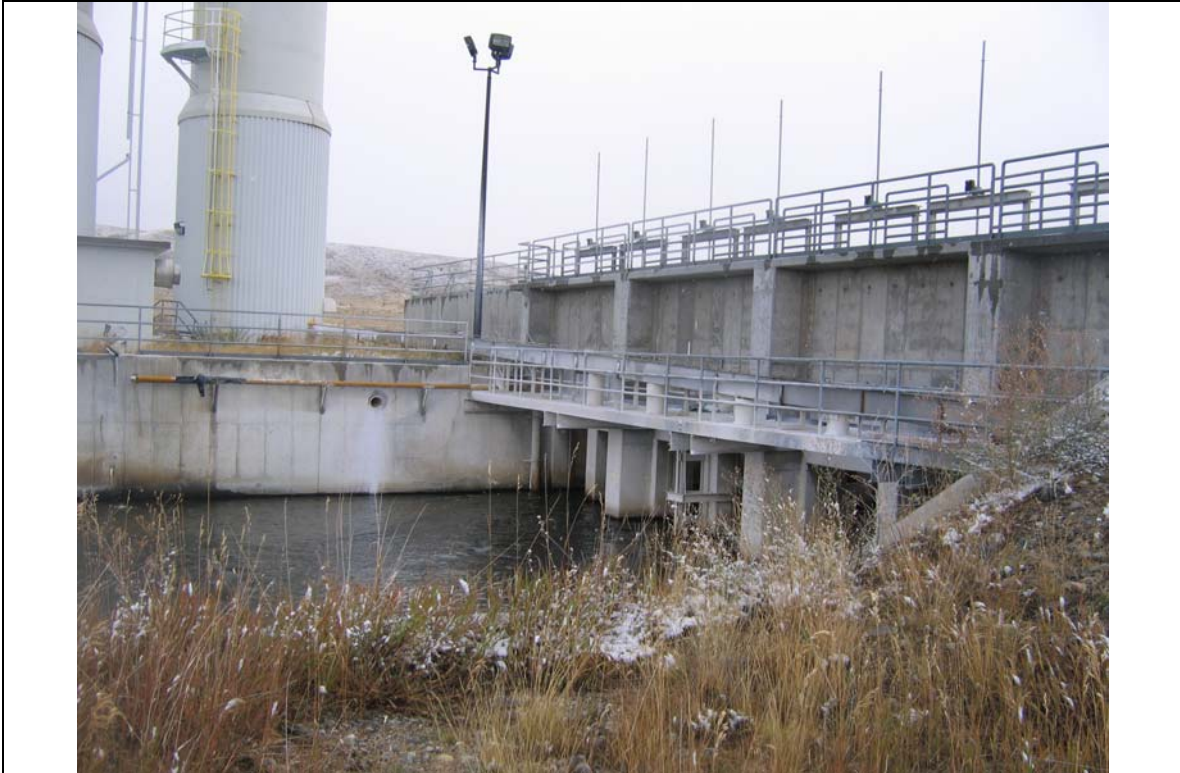
Photo 2. Downstream side of the WSP hydraulic control structure with lime silo towers in background left.

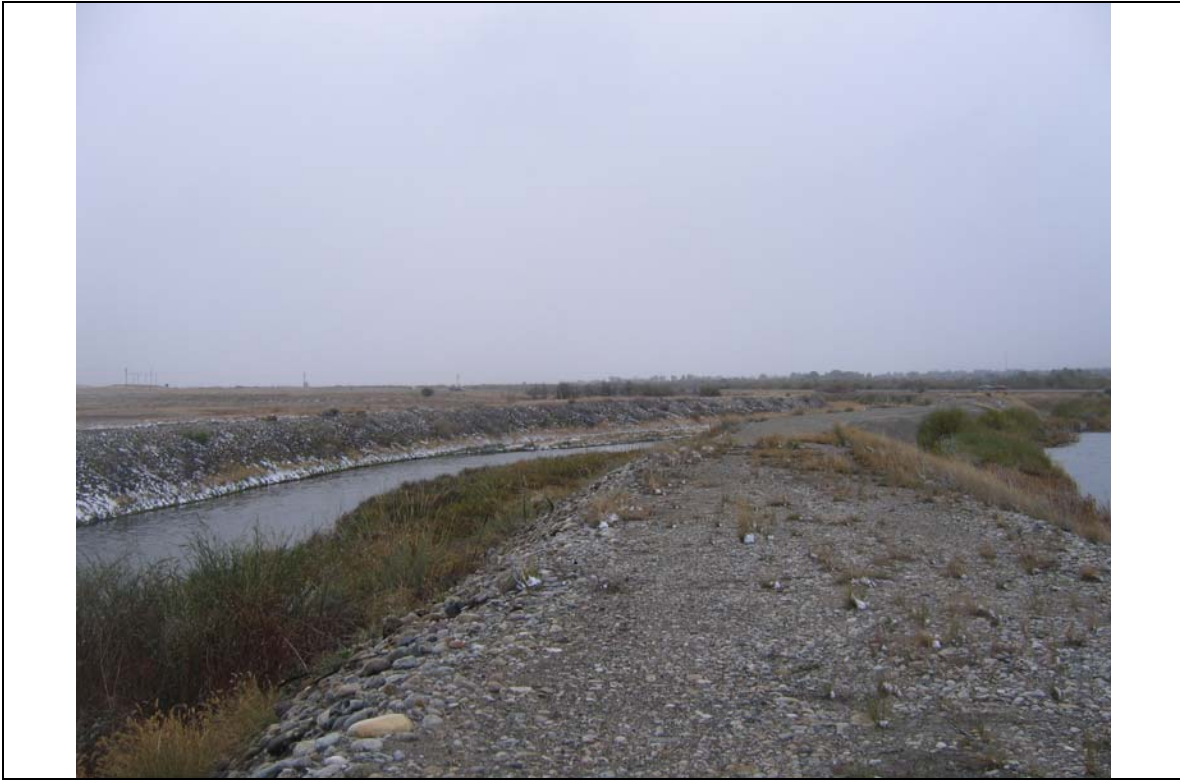
Photo 3. Looking upstream along Silver Bow Creek (left side) from the WSP inlet berm. Mill-Willow Bypass is on the right side.

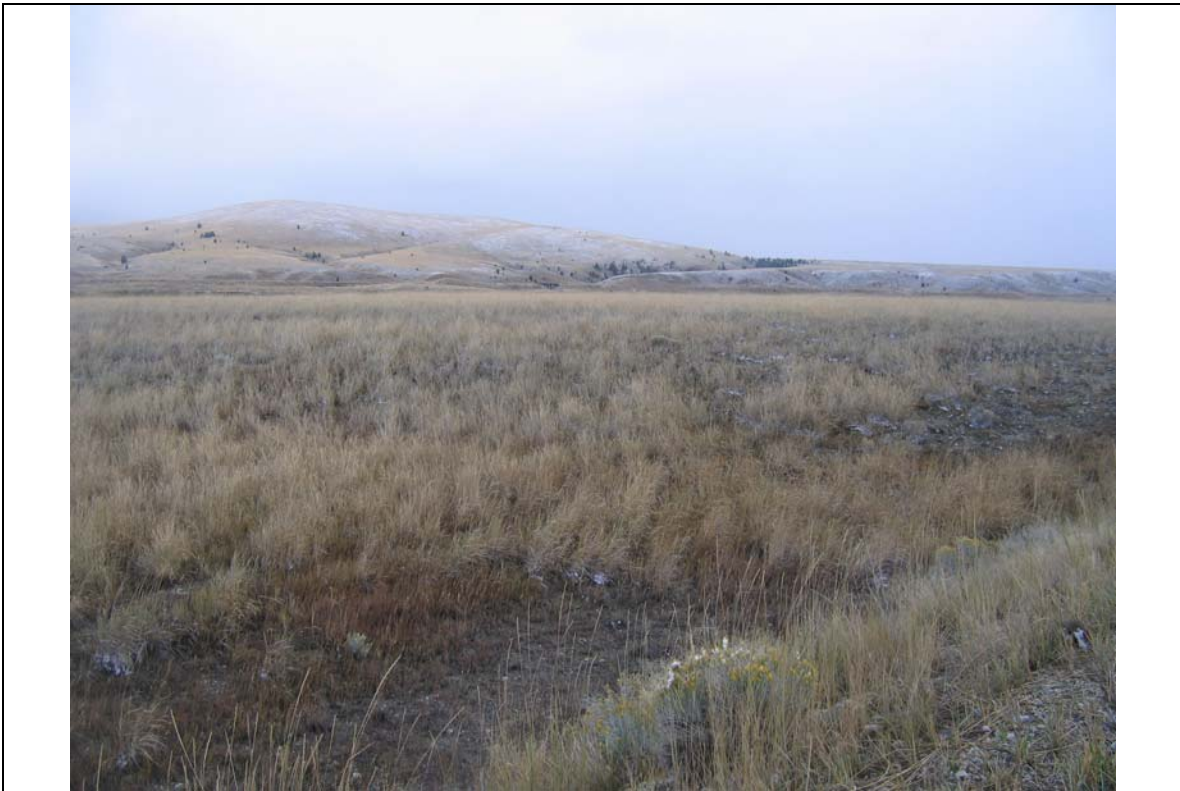
Photo 4. Waste Cap at the WSP upgradient from the Wet Closure Ponds.

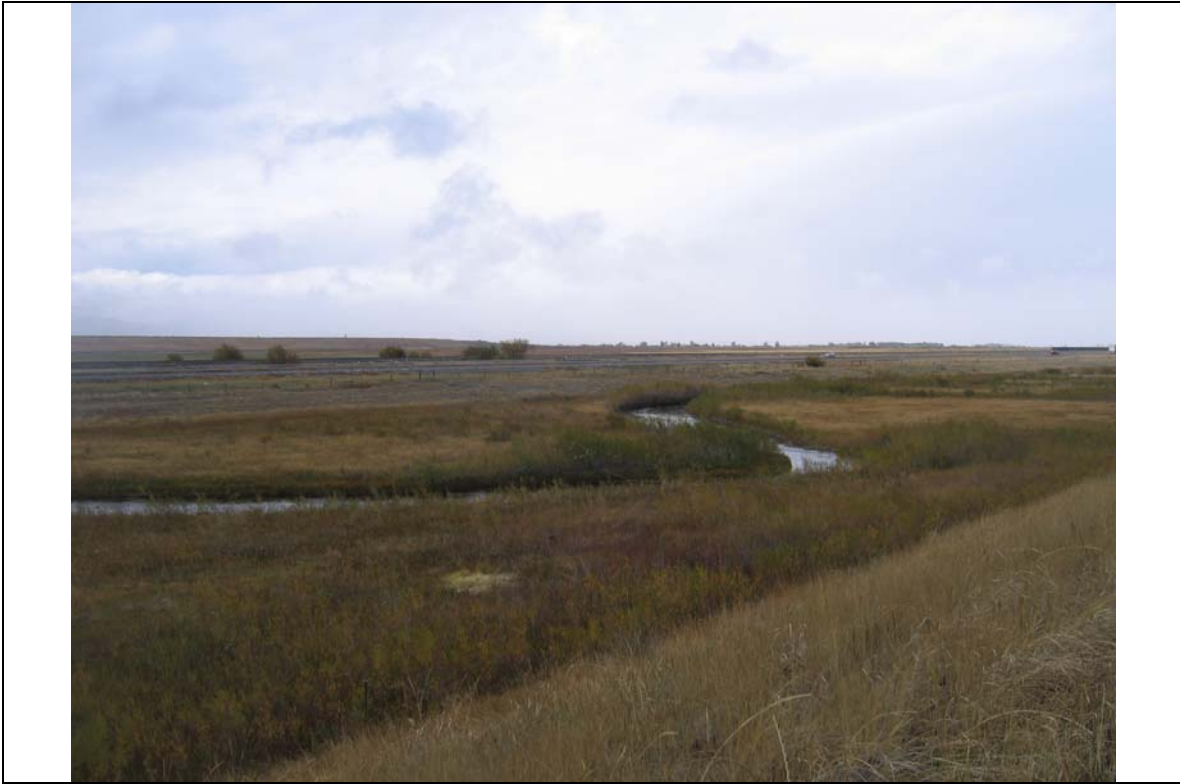
Photo 5. Meandering Mill-Willow Bypass with healthy vegetation growth along banks.

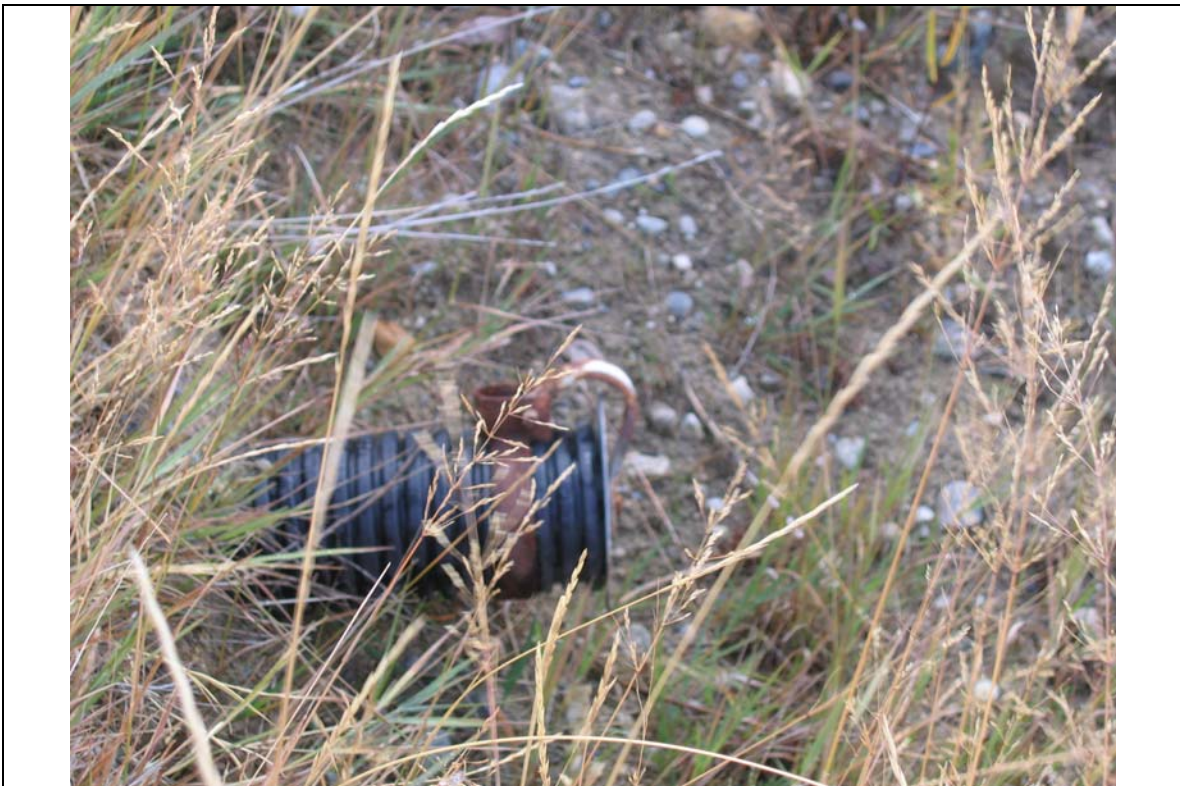
Photo 6. One of many toe drains along Pond 3 dam adjacent to Mill-Willow Bypass.

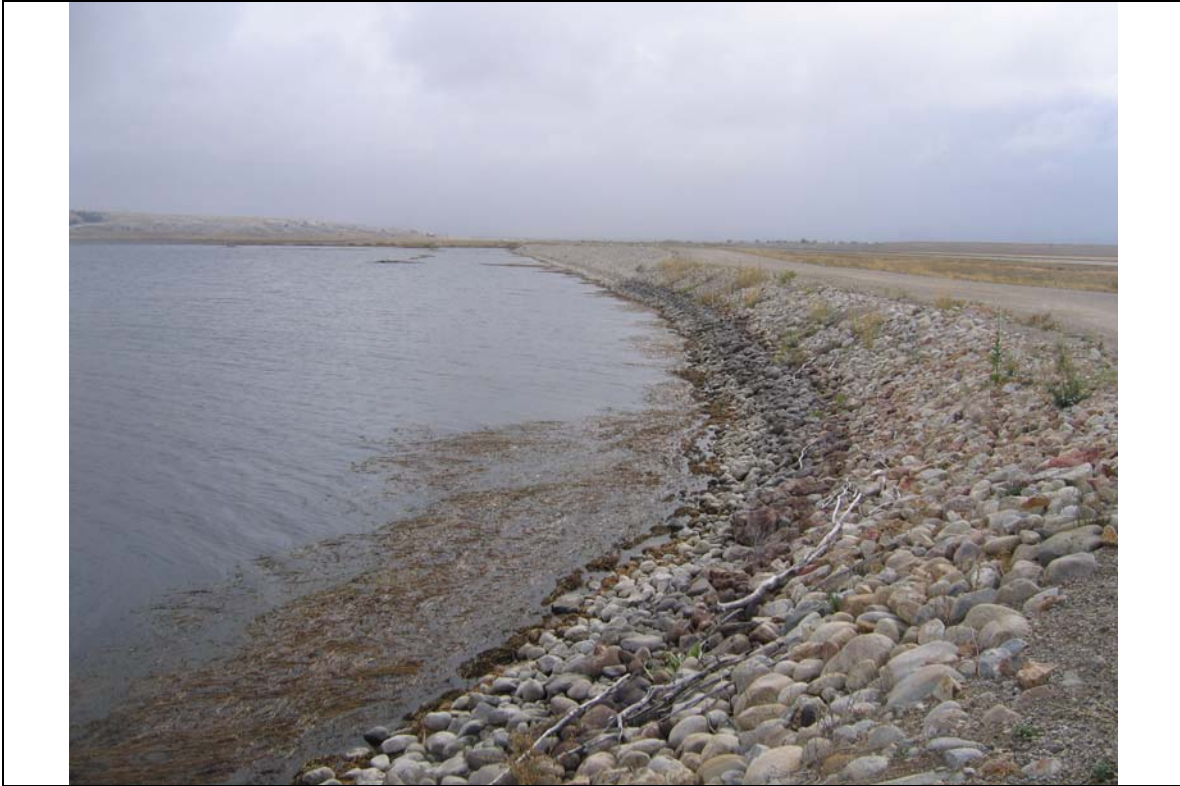
Photo 7. Riprap repair work to protect against wave run-up along banks of Pond 2.

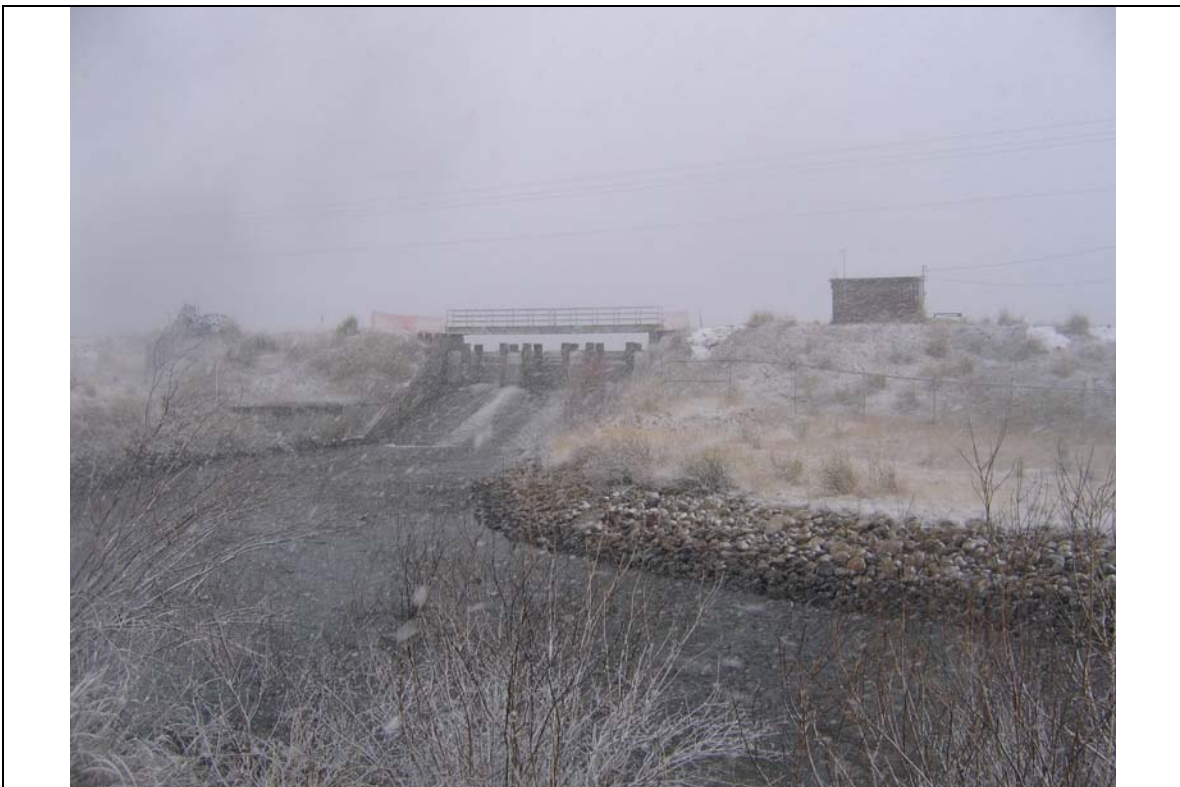
Photo 8. Pond 2 discharge hydraulic control structure (station SS-5).

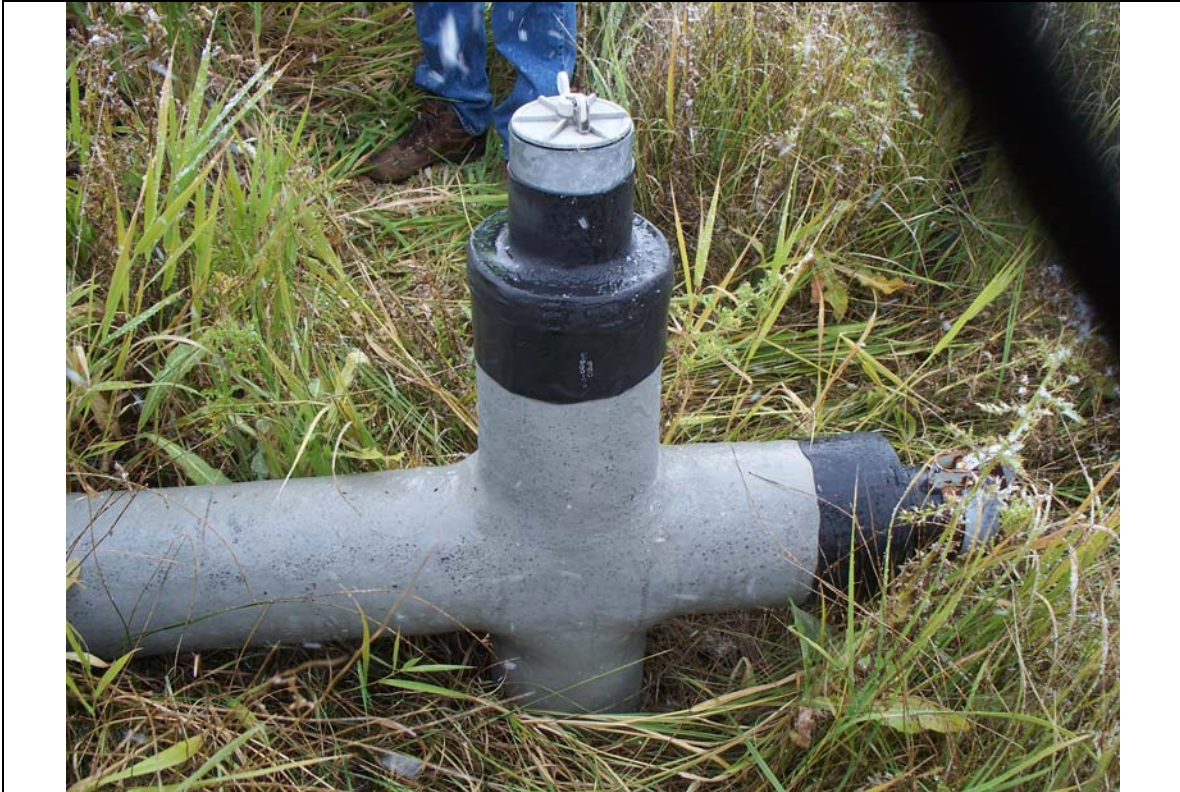
Photo 9. Manifolded Toe Drain.

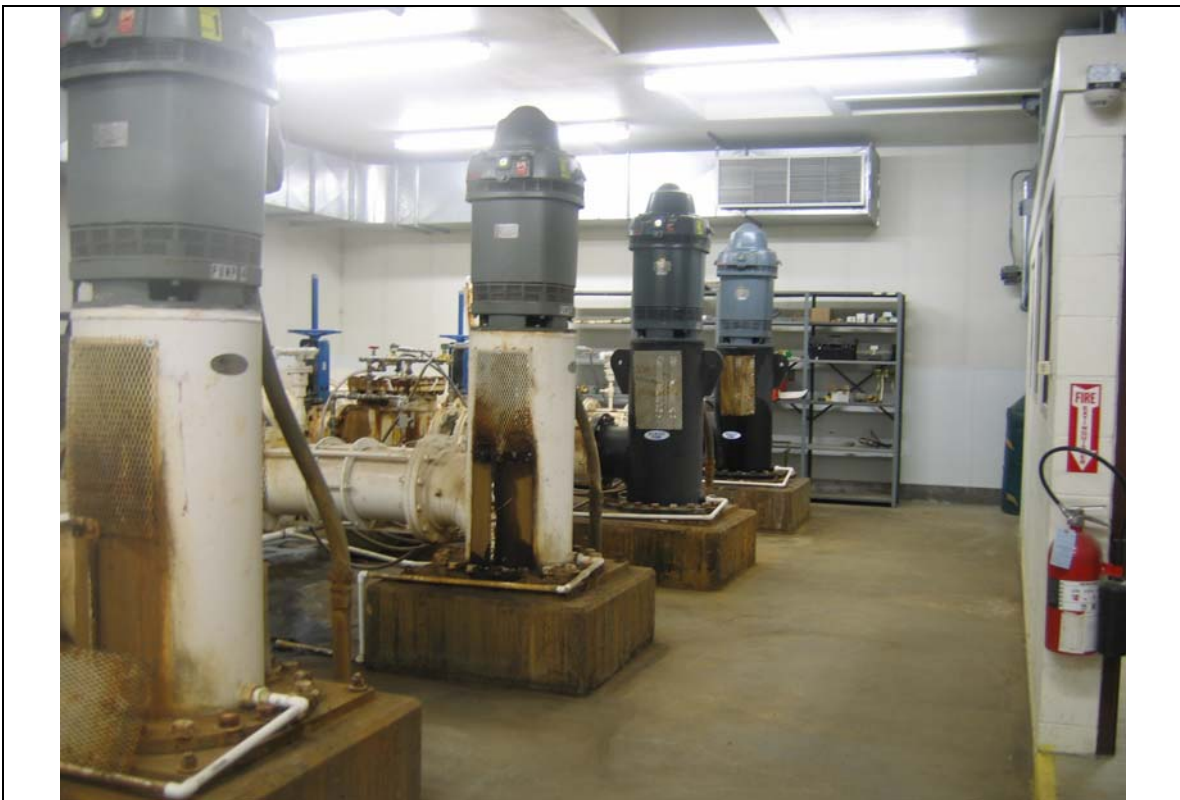
Photo 10. Groundwater interception channel pump house.
